## Town of Holden

### *Town and School Building Assessments*

Various Locations  
Holden, MA

January 31, 2019

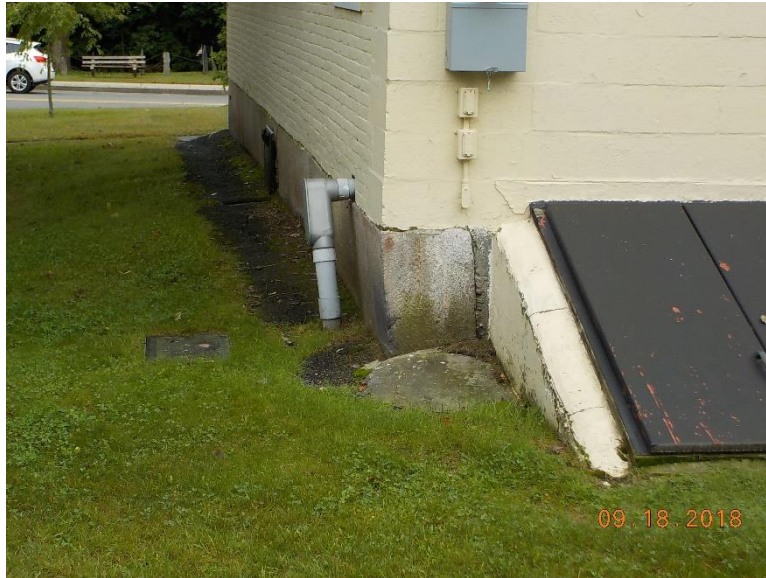
*Figure No. 1 – Rotated Cut Stone Piece in the Sidewall Foundation*

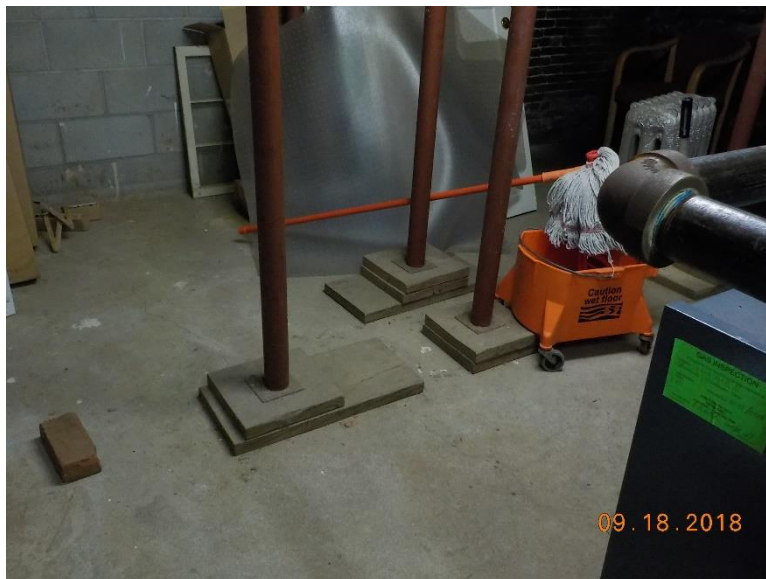
*Figure No. 2 – Base of Steel Basement Pipe Columns Supported on Wood Blocking on Top of the Basement Level Concrete Floor Slab*

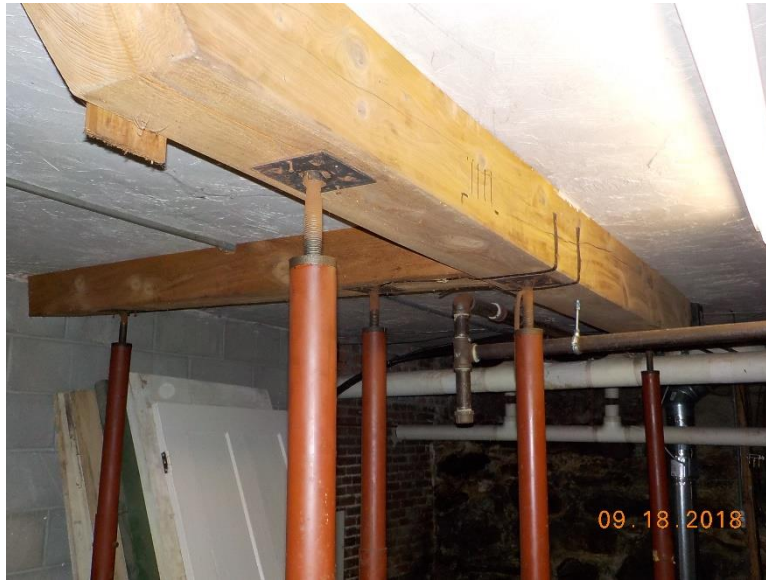
*Figure No. 3 – Basement Level Temporary Timber Reinforcement Floor Beams and Temporary Adjustable Steel Shoring Posts*

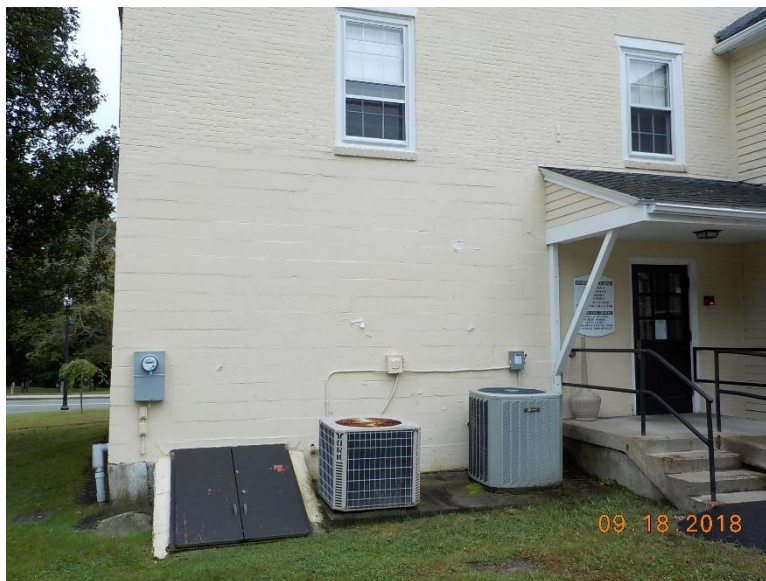
*Figure No. 4 – Exterior First Floor Level CMU Masonry Bearing Wall at the Rear Wall of the Starbard Building*

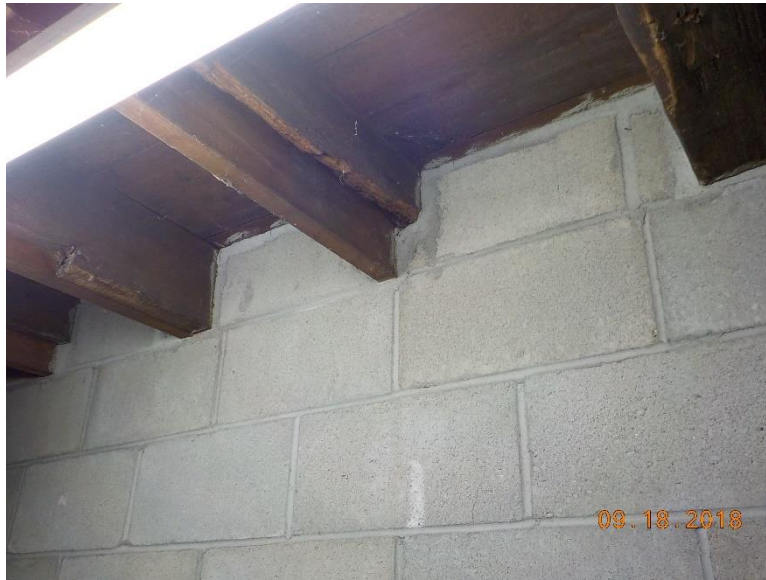
***Figure No. 5 – Timber First Floor Framing in Direct Contact With CMU Masonry Wall Construction at the Basement Level***

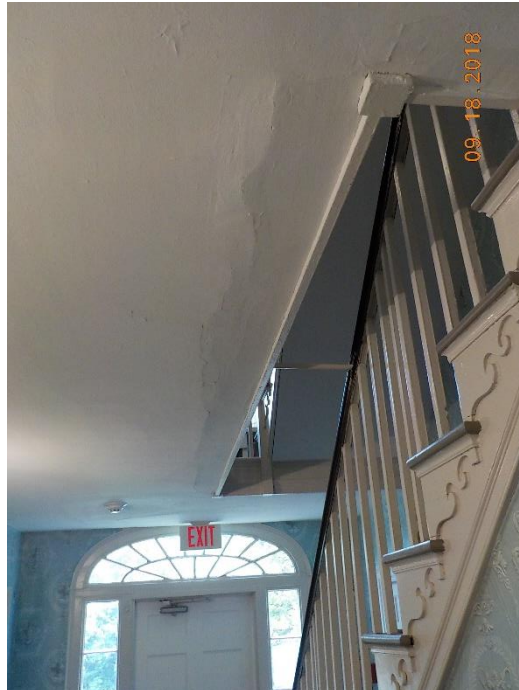
***Figure No. 6 – Plaster Distress at 2<sup>nd</sup> Floor Framing at Stairway Opening***

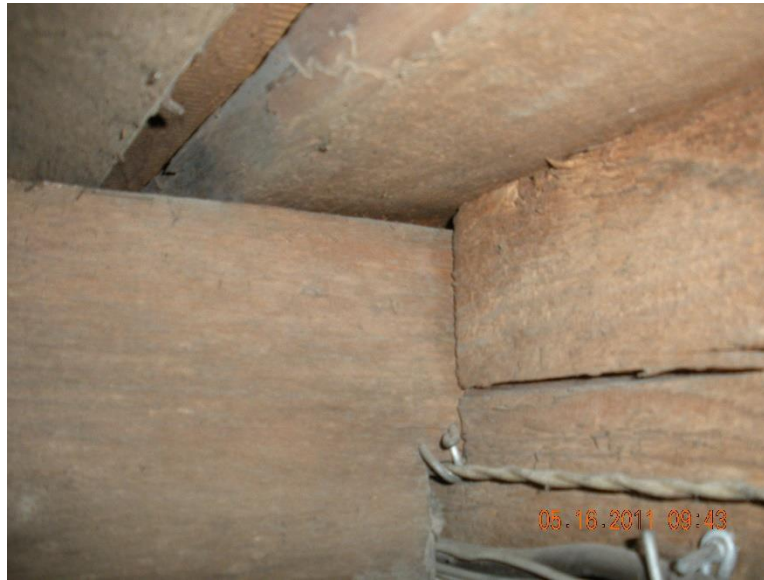
***Figure No. 7 – Anticipated Timber Framing Connection Damage at the Side of the Main Stairway Floor Opening at the 2<sup>nd</sup> Floor Level***

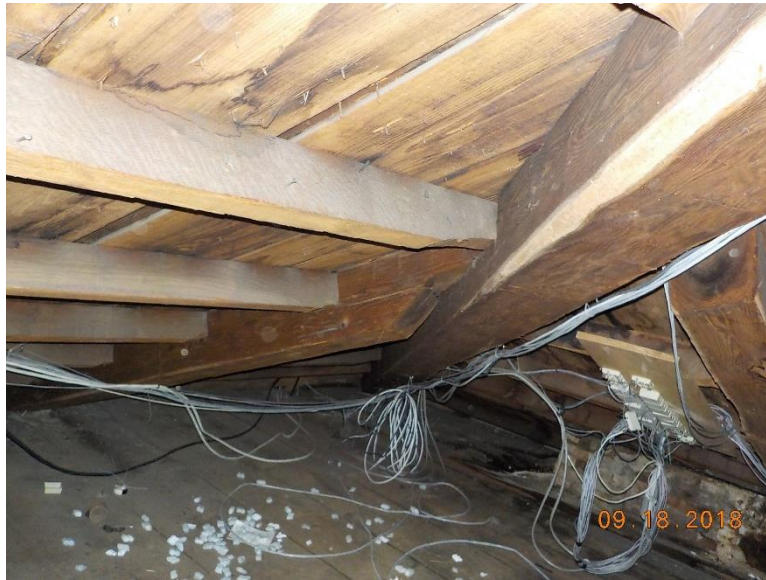
***Figure No. 9***– Typical Horizontal Shear Failure in Infill Roof Beams at the Bottom of the Mortise Cuts at the Flush Framed Connections with Roof Purlins at Each Side of the Main Roof Hip Beams

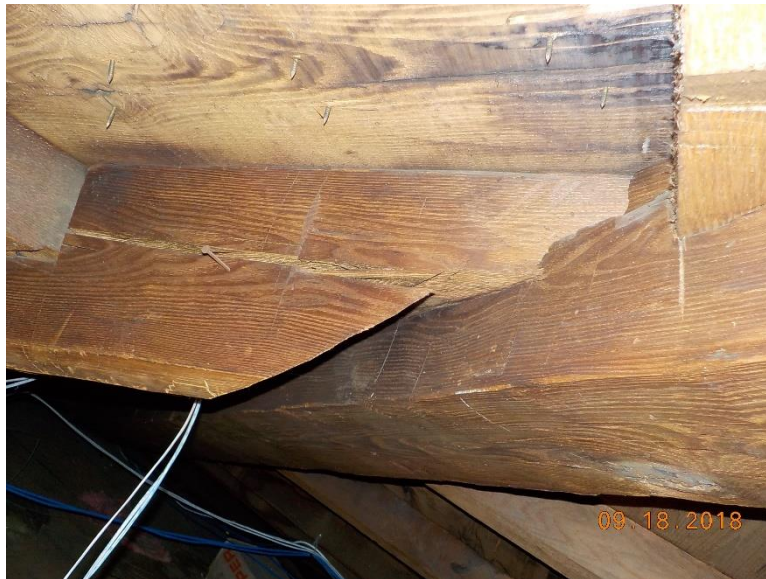
***Figure No. 10***– Close Up View of Typical Horizontal Shear Failure at the Bottom of Tenon Cut Top Ends of an Infill Roof Beam at the Flush Framed Connection at the Side of the Main Roof Hip Beam

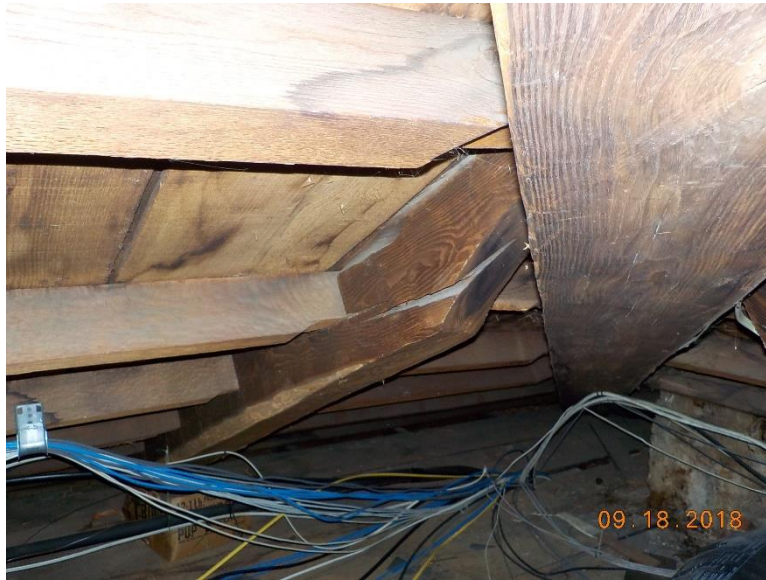
***Figure No. 11*** – Close Up View of Typical Horizontal Shear Failure at Bottom of Mortise Cuts at the Side of an Infill Roof Beam at the Flush Framed Connection with a Roof Purlin Adjacent to a Main Roof Hip Beam

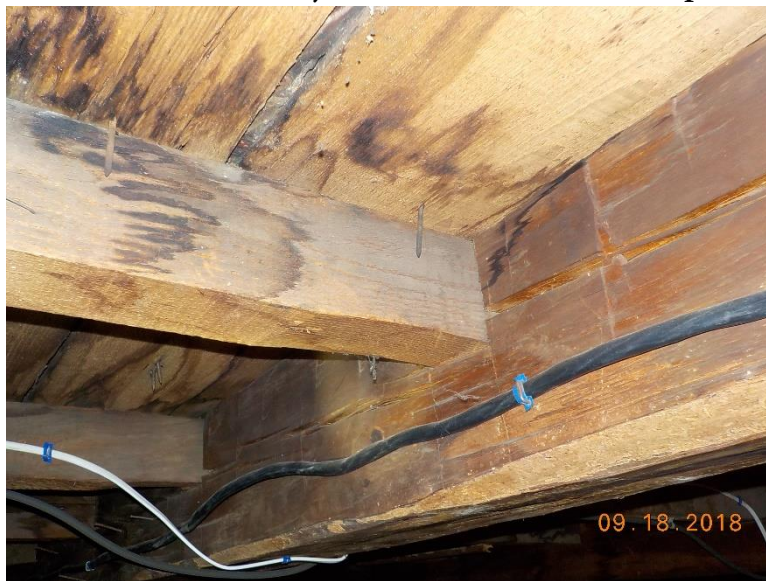
***Figure No. 12*** – Typical Horizontal Shear Failure of Main Roof Beam at the Bottom of the Mortise Cuts for the Flush Framed Connections With Tenoned Ends of the Roof Purlins

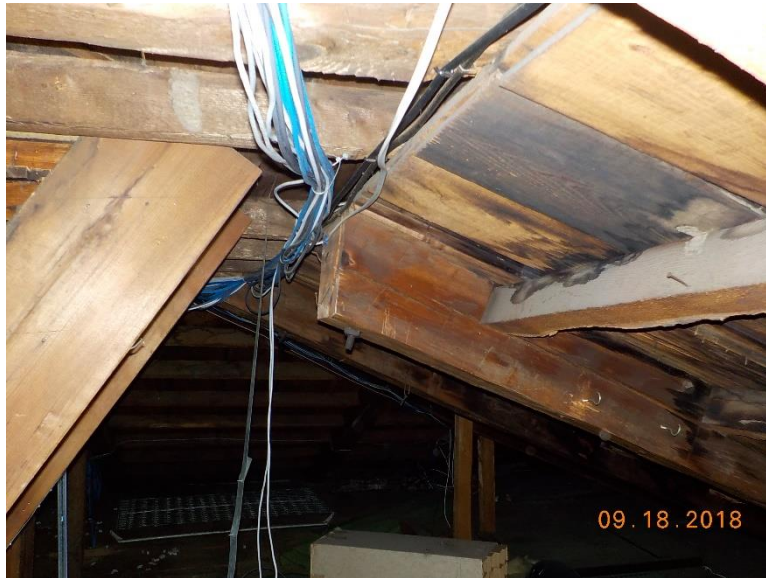
**Figure No. 13** – Typical Horizontal Shear Failure of Main Beam at the Bottom of Mortise Cuts for Flush Framed Connections With Roof Purlins at Side of Roof Opening for the Roof Cupola

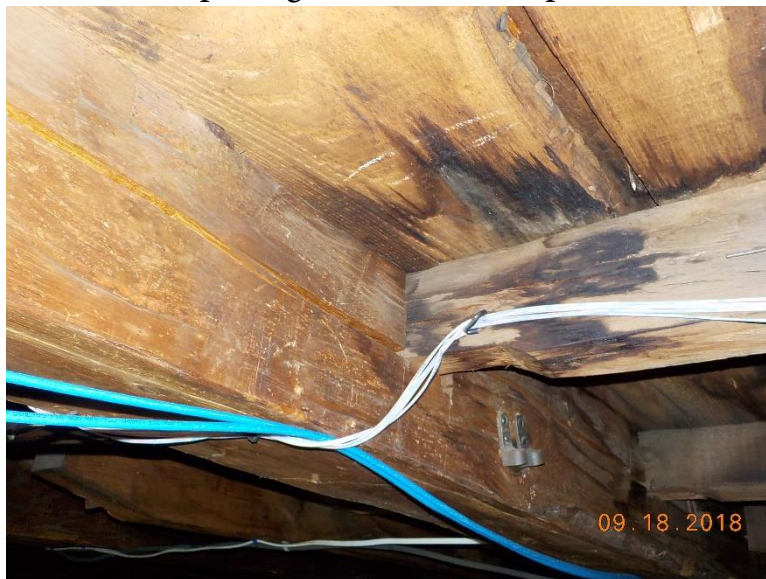
**Figure No. 14** – Typical Horizontal Shear Failure of a Main Roof Beam at the Bottom of Mortise Cuts for Flush Framed Connections With the Tenoned End of a Typical Roof Purlin

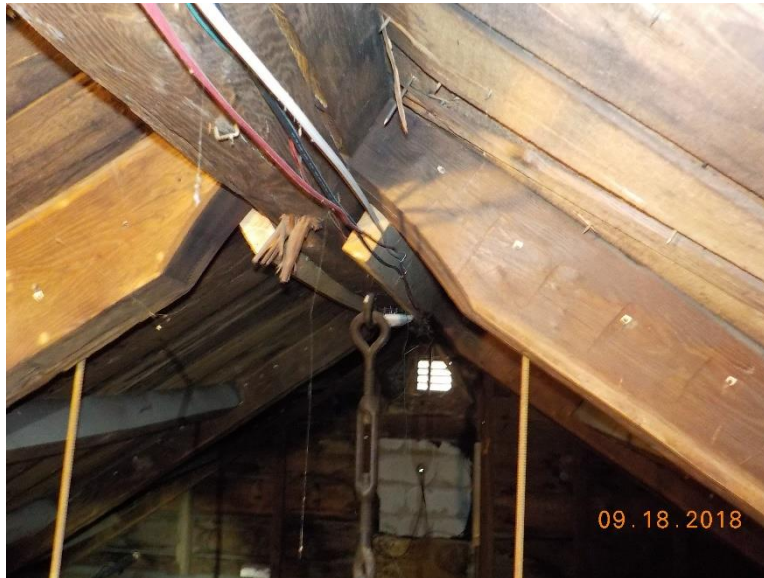
***Figure No. 15*** – Typical Horizontal Shear Failure of Main Roof Ridge Beam at the Rear Building Wing at the Bottom of the Mortise Beam Cuts at the Flush Framed Connections With the Tenoned Top Ends of the Main Sloped Gable Roof Beams
