Town of Holden

Town and School Building Assessments

Various Locations
Holden, MA

F.4 ISSUES PHOTOS CHART

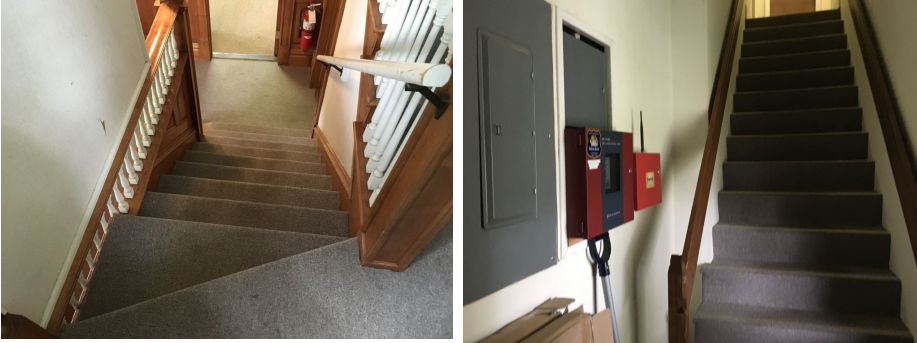
#	Issue	Photos
25	Non-Compliant Handrails <i>Stairs</i> - The two stair do not have accessible handrails.

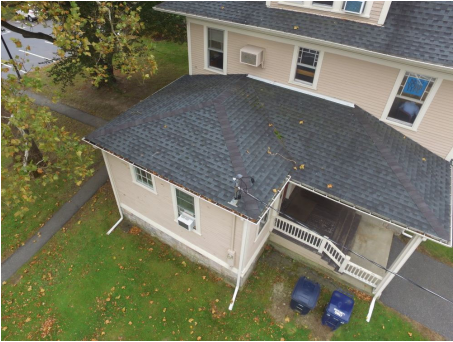
26	Asphalt Shingle Deterioration <i>Roof</i> - Especially at the low roof, the shingles are worn and algae is growing.

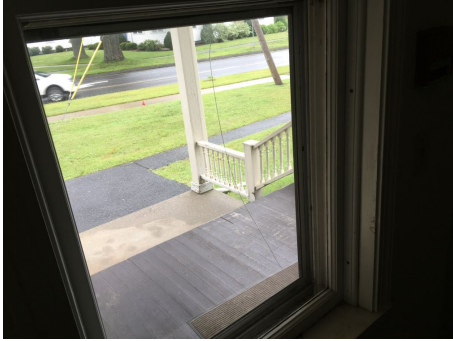
#	Issue	Photos
27	Cracked Glass Storm Windows <i>Multiple locations</i> - At two locations, the glass storm window is cracked.

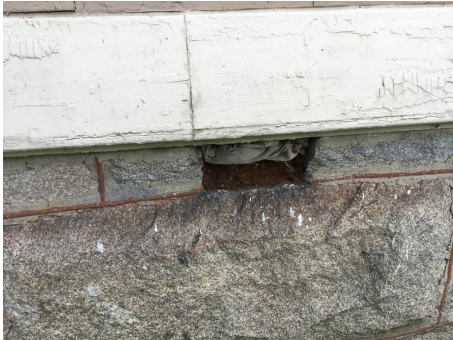
28	Foundation Masonry Items <i>Exterior</i> - The masonry foundation is dirty and there are some holes that have been stuffed as a temporary measure to close up unused openings.

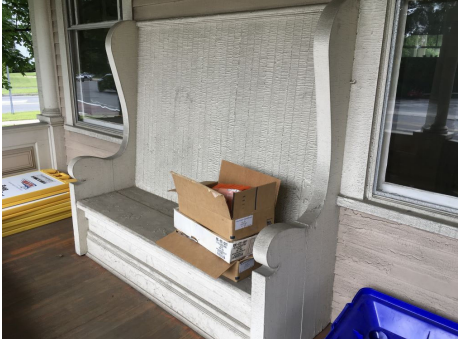
#	Issue	Photos
30	Paint Peeling (Exterior) <i>Exterior - The paint is peeling off the exterior siding, trim, soffits, and other features</i>

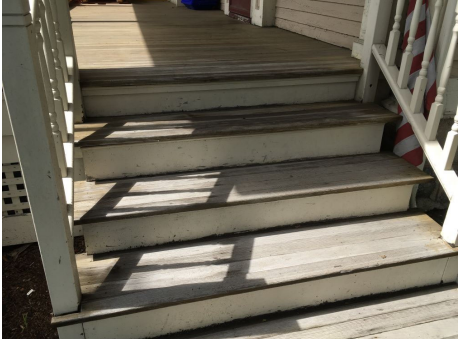
31	Wood Deck Finish Deterioration <i>Exterior Steps and Porches (3 locations) - The finish on the exterior steps and porches has faded.</i>

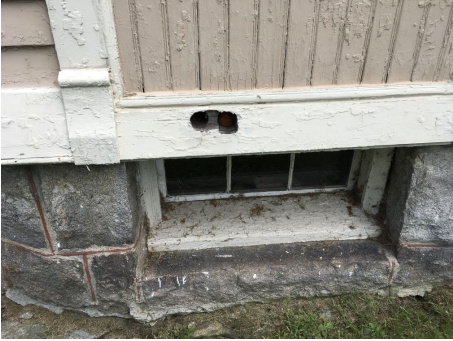
#	Issue	Photos
32	Wood Trim Holes <i>Various Locations (Qty: +/-3) - There are a couple of locations where holes were made in the exterior trim that are currently unused.</i>

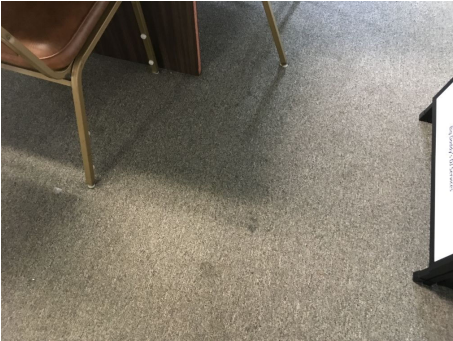
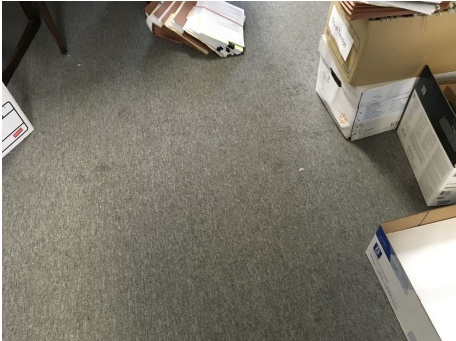
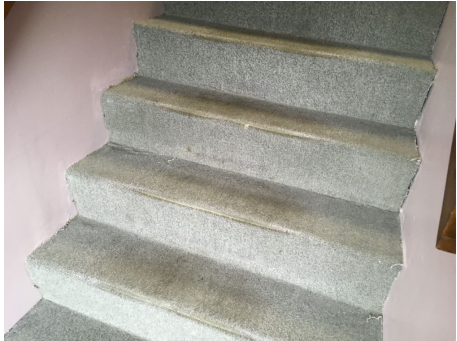
33	Wood Windows in Poor Condition <i>Entire Building - Windows do not operate easily.</i>	
34	Carpet in Poor Condition <i>Entire Building - The carpet is in poor condition.</i>

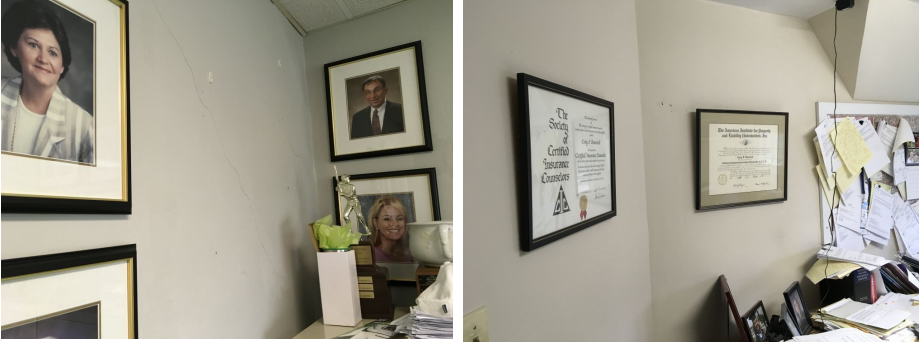
#	Issue	Photos
35	Paint Damage (Interior) <i>Entire building (interior)</i> - Cracks and scuff marks have appeared on the painted walls.

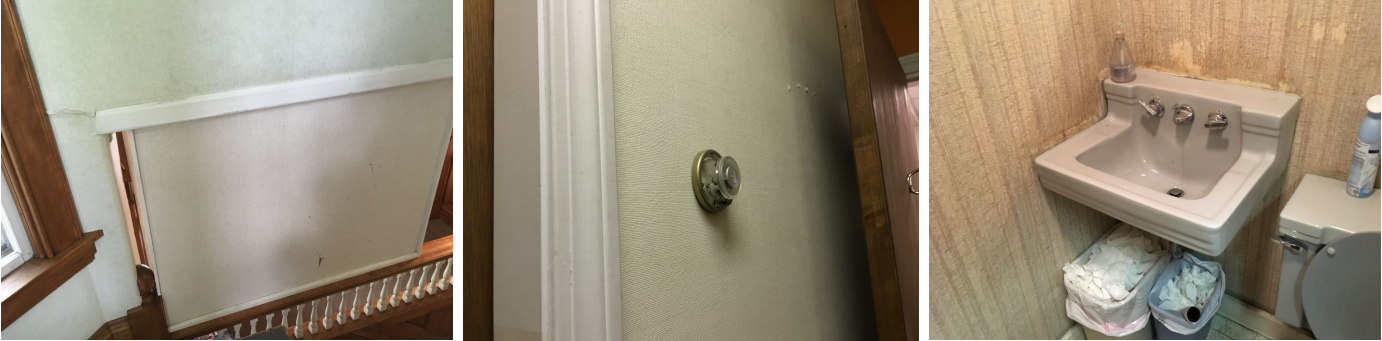
36	Wallpaper Damage <i>Various Locations (i.e. Lobby)</i> - Some of the wallpaper is peeling.

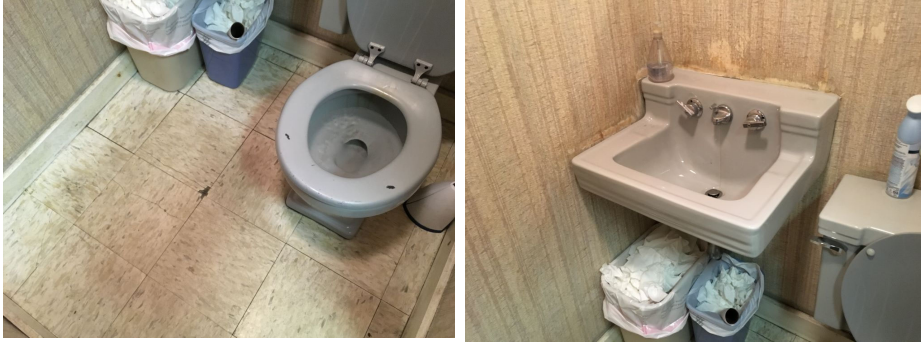
#	Issue	Photos
38	Dated Plumbing Fixtures <i>Bathrooms</i> - The plumbing fixtures are old.

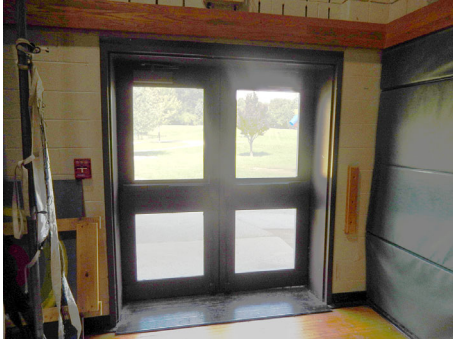
53	Door Opening Issue (Gym Emergency Exit) <i>Gymnasium at Far End Emergency Exit - One 2'10" wide leaf of an emergency exit door does not open.</i>

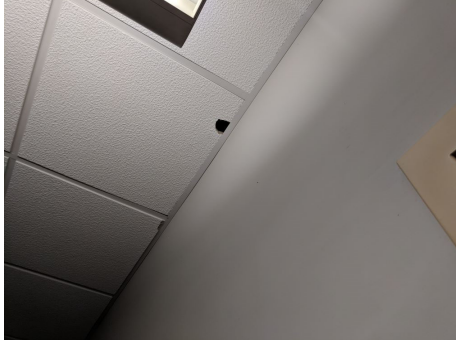
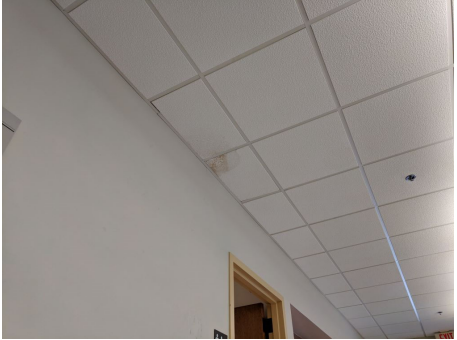
68	Ceiling Tile Damage <i>Entire Building</i> - There is moderate damage to ceiling tile throughout building; mostly chips, some stain.

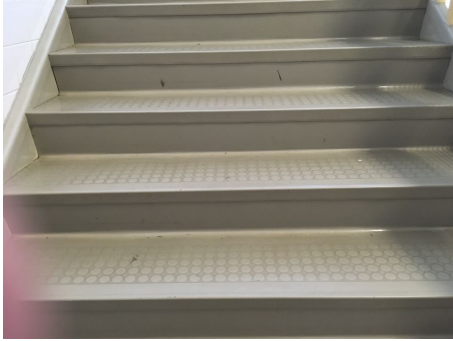
#	Issue	Photos
73	Stair Tread Scuffs <i>Stairs</i> - The stair treads are showing wear and tear.

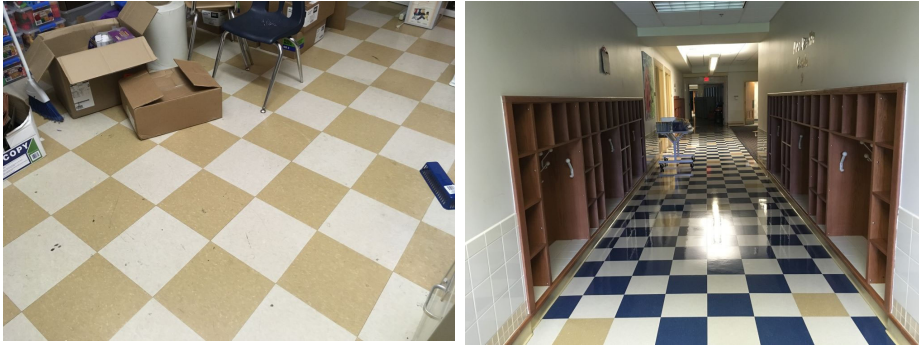
74	VCT Flooring Damage <i>Various Locations</i> - The VCT flooring is mostly in good shape except in storage rooms.

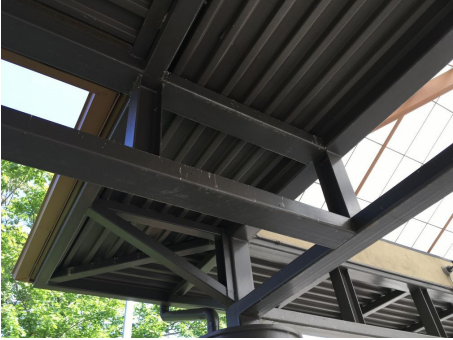
Capital Improvement and Maintenance Plan		
ISSUES PHOTOS		
#	Issue	Photos
109	Canopy Finish Damage <i>Exterior, Various Locations</i> - Where there are metal canopies at entrances, the paint is worn and there are bird droppings.

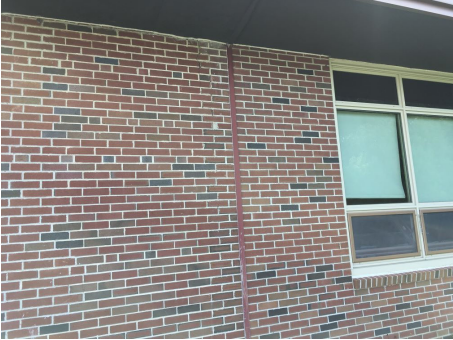
110	Masonry Crack <i>Rear Side of Left Wing</i> - There is a crack through the masonry from soffit to foundation.

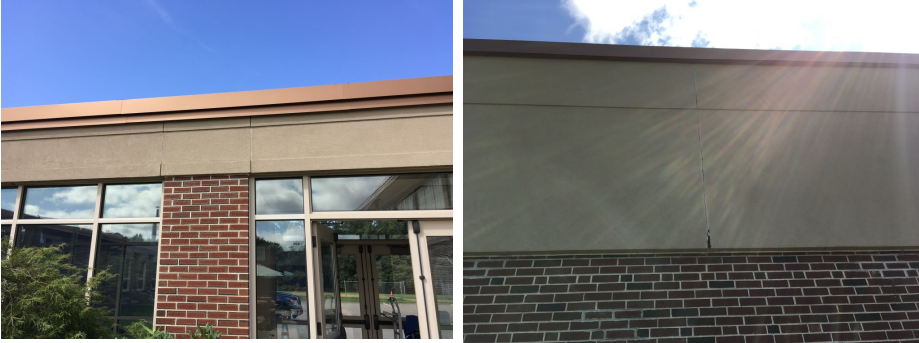
112	Sealant Failure at EIFS <i>Exterior</i> - The sealant at the EIFS is starting to fall out.

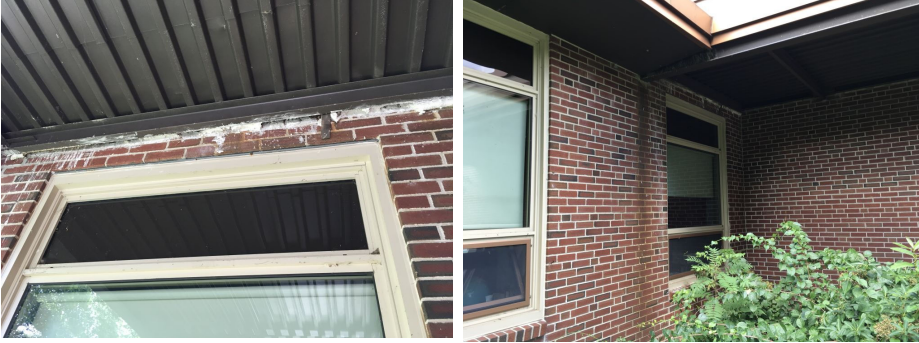
#	Issue	Photos
113	Spray Foam Insulation Deteriorating <i>Exterior, Left of the Cafeteria - A gap between a metal canopy and the wall was previously filled with spray foam insulation likely to prevent bugs from getting in. The insulation is started to deteriorate.</i>

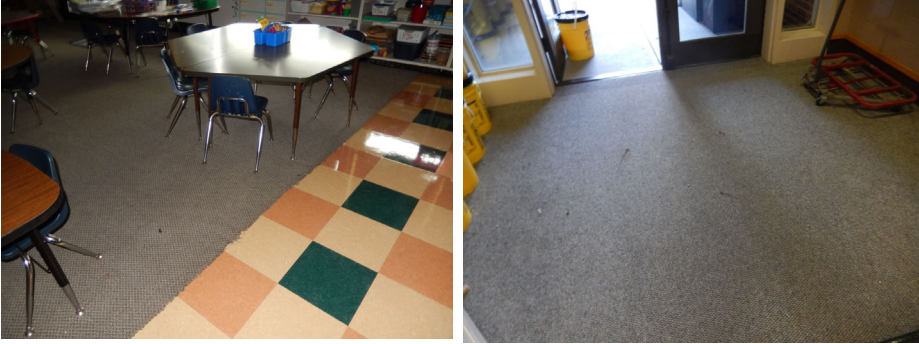
114	Carpet Worn <i>Various Locations (Small Offices) - In areas with carpet, the carpet is slightly worn.</i>

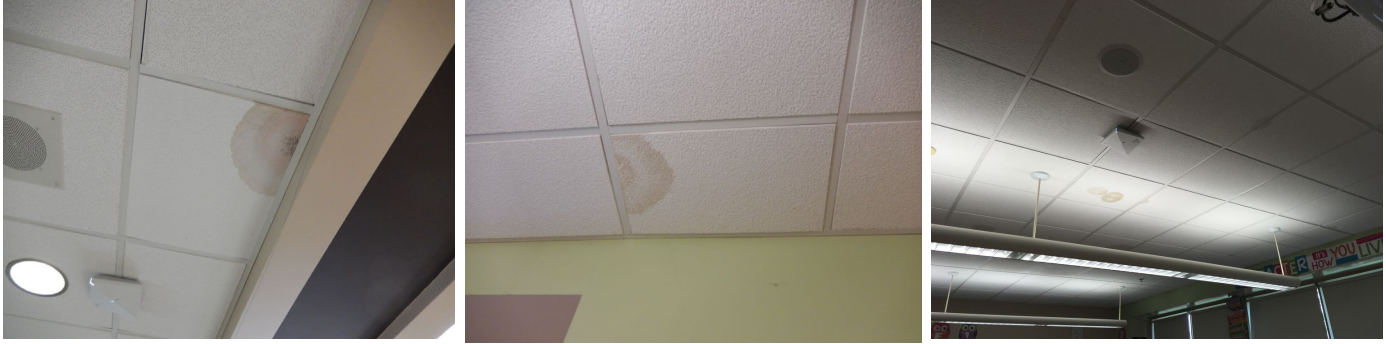
#	Issue	Photos
115	Ceiling Tiles Damage <i>Entire Building</i> - Several ceiling tiles are stained throughout the building, which may be coming from a leaking room (see "Roof Age Concern").

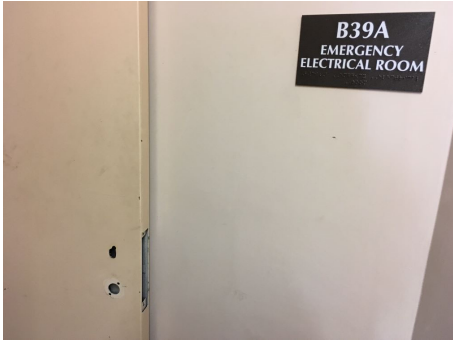
116	Door and Sidelight Frame Rusty <i>Outside room #B55</i> - The inside of the sidelight frame is rusty and there is a large hole in the frame.	
117	Door Hardware Missing (Emergency Elec.) <i>Emergency Electrical Room (B39A)</i> - The door lockset on the Emergency Electrical Room door is missing.

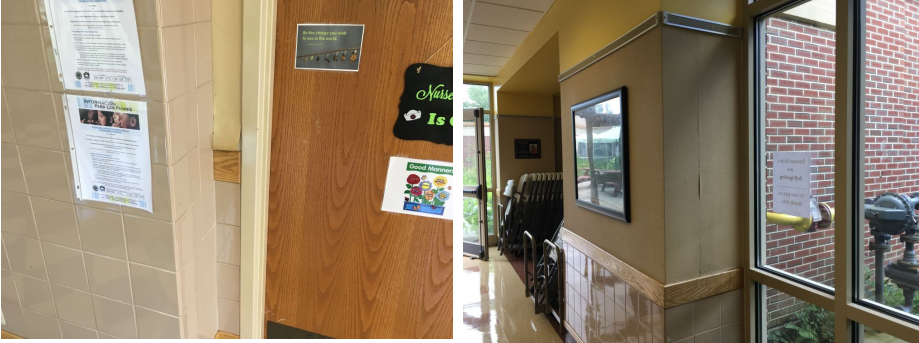
#	Issue	Photos
123	Wallpaper Detaching <i>Corridors</i> - Some of the wallpaper is starting to detach.

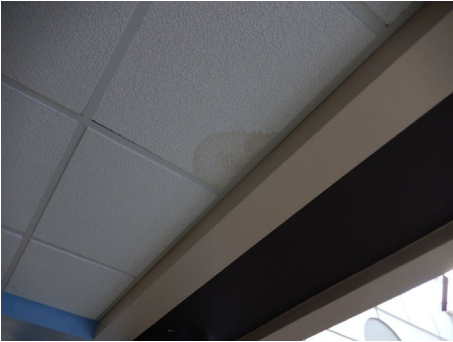
124	Water Damage from Roof <i>Area of large skylight over library</i> - There are 4 stained ceiling tiles below two roof drains, and moss growth at one drain. Drain covers are missing. (See also "Roof Age Concern".)

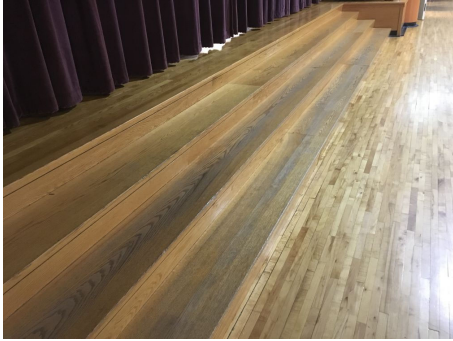
#	Issue	Photos
125	Wood Stairs at Stage Worn <i>Gym</i> - The stair steps are worn.

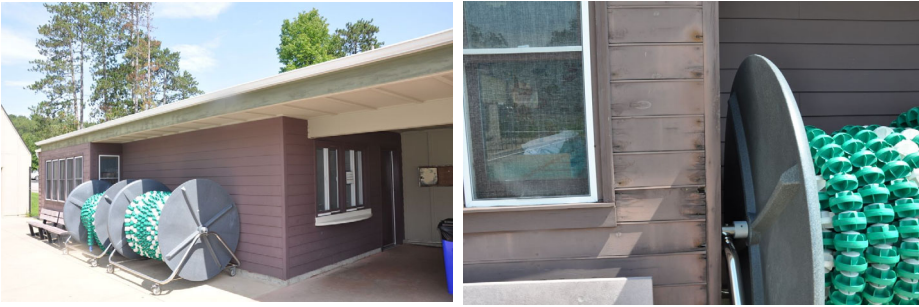
#	Issue	Photos
151	Siding Aged (Life Guard Building) <i>Life Guard Building (East)</i> - Siding showing its age.

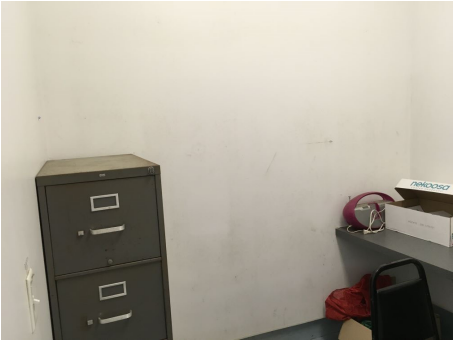
153	Scuffs on Walls <i>Entire building</i> - There are scuffs on the wall and some wear.

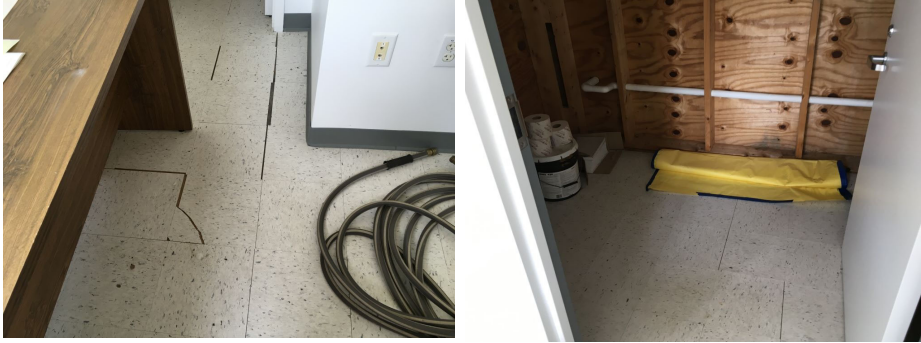
#	Issue	Photos
154	VCT Tile Damage <i>Second Floor</i> - In the office and adjacent storage room and toilet room, the VCT has popped off likely from temperature extremes on the glue.

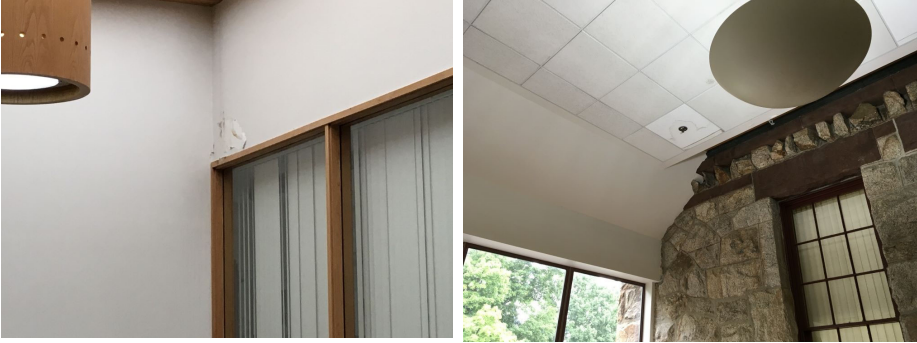
Capital Improvement and Maintenance Plan		
ISSUES PHOTOS		
#	Issue	Photos
183	Water Infiltration (Atrium, Newer Addition) <i>Second Floor Ceiling and Walls</i> - There is a roof leak above the atrium in the newer addition.

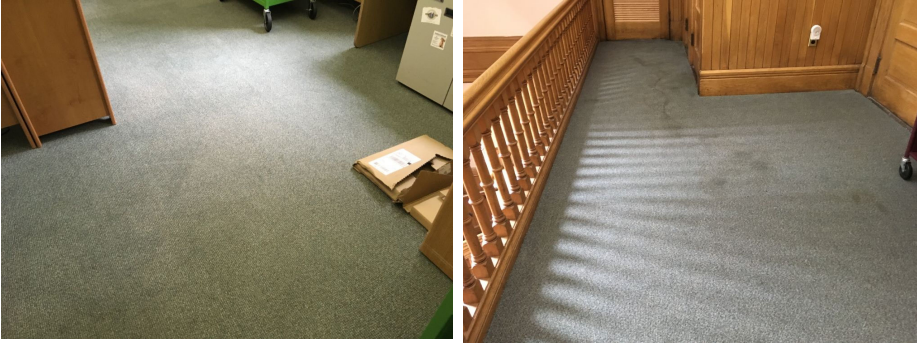
#	Issue	Photos
187	Carpet Worn <i>Entire Building</i> - The carpet is showing signs of its age.

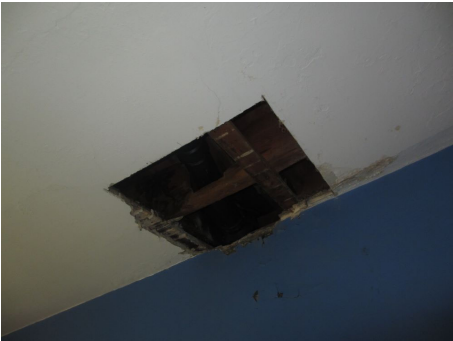
207 **2x2 Holes Cut In Ceiling**
Kitchen - Saw cut opening in lath and plaster ceiling from previous repair or upgrade.

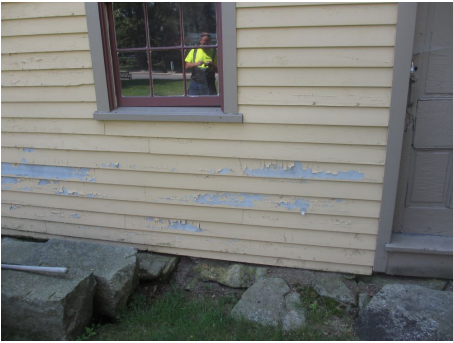
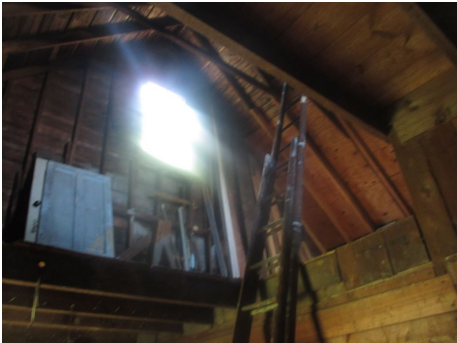
228 **Rotted Damaged Windows**
Exterior Walls - Wood windows are broken and rotted. Water can enter the barn.

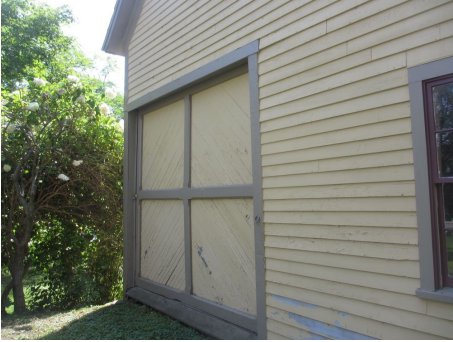
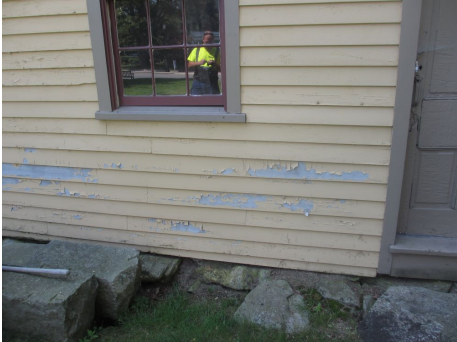
229 **Siding in Poor Condition**
Entire Building - Paint is peeling and wood is rotted.

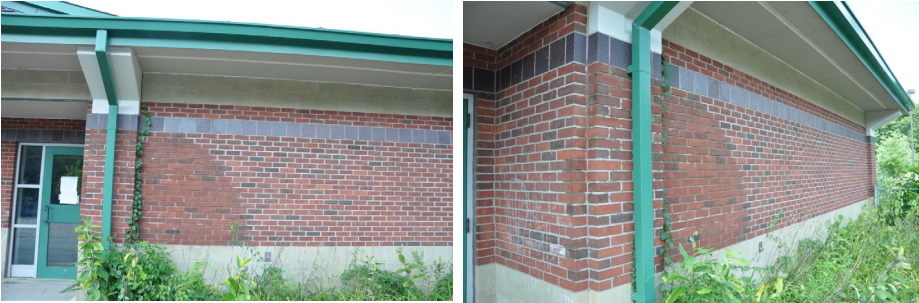
244	Masonry Water Infiltration Stain (Exterior) <i>South Facade, Right of Pod Door - The masonry to the right of the exterior door to the central pod is stained. This includes a flat wall as well as a pilaster. The cause of the water is unclear and at the time of the assessment, those interior rooms could not be accessed.</i>

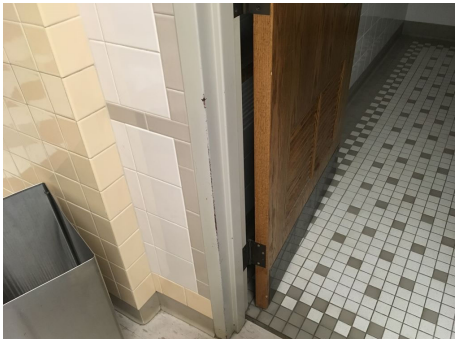
250	Head Protection on 2 Backboards <i>Gym</i> - The padding on the bottom of the two main backboards is missing.	
251	Metal Door Frame Damage <i>Entire Building</i> - Many metal door frames are damaged down low. Paint is chipped off.

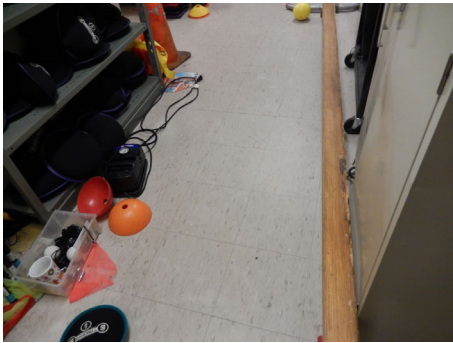
254 **VCT Floor Damage**
Gym Equipment Room - The VCT is damaged and scarred.

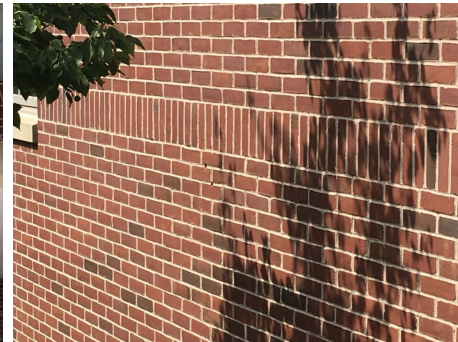
Brick Exterior - Couple of holes and missing mortar

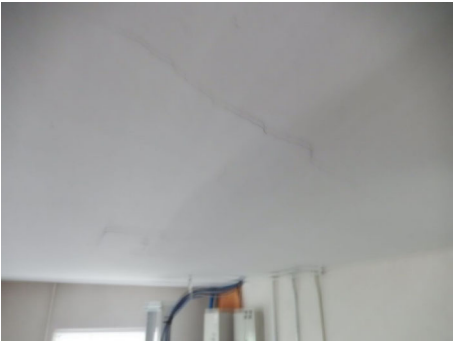
397	Ceilings Cracked <i>Third Floor</i> - Plaster ceiling has cracked. See also "Structural Issues".

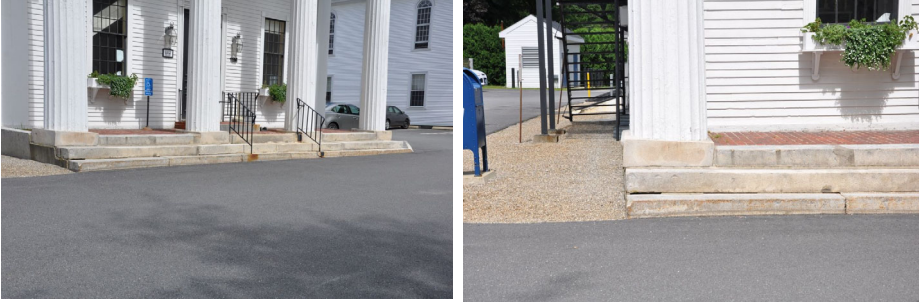
431	Ceiling Insulation Exposed to Moisture <i>Basement Ceiling</i> - Very moist environment. Fiberglass batts at first floor framing is uncovered.	
432	Column Base Settlement <i>Front Columns</i> - The stone base for the front left column has settled and is not level.

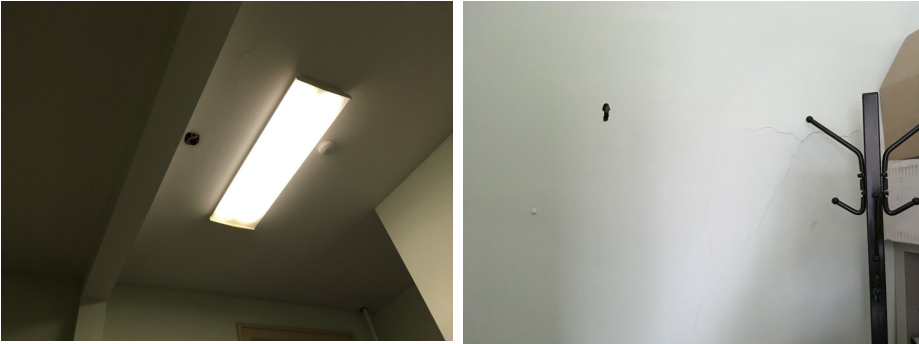
457	Wall/Ceiling Holes at Various Locations <i>Various Locations (Qty: 2)</i> - There are a couple of locations where the the gypsum board is damaged. One is at a ceiling where a removed device left a hole. Another is a hole created by a coat hook.
