## Town of Holden

### *Town and School Building Assessments*

Various Locations  
Holden, MA

January 31, 2019

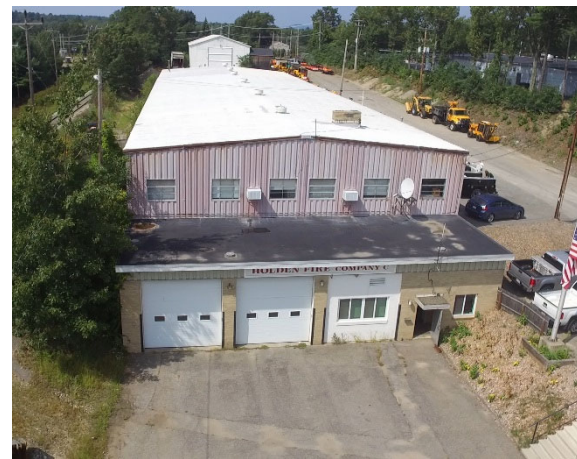
- B. At the time of Gienapp Design's walkthrough, the Town reported the building is partially occupied by a volunteer crew. However, the Town plans to change this to a fully occupied sub-station with a permanent crew. It should be noted that the building does not have many of the features or meet the requirements of a fully used fire sub-station. It is questionable if the current sub-station can be renovated such to meet these requirements due

Photo 1: Chaffins Sub-Station (Lower, Front Portion Only)

to its limitations in size, shape, and configuration, so it may be to the Town's benefit to review opportunities to construct a new station. If the DPW portion is demolished, the land could provide one of these opportunities.

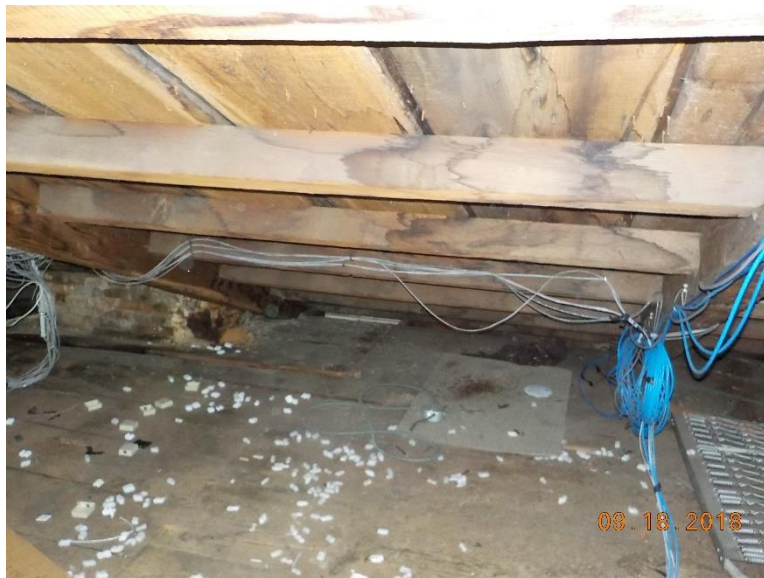
In general, the majority of the timber hip roof framing system in the *Starbard Building* was exposed to view in the Attic space because there were no finish materials on the underside of the roof framing. As was anticipated given the age of the building and based on IREI's field observations of the portions of the existing timber roof framing that were exposed to view, the existing timber roof framing system in the building appears to be a typical post and beam timber framed roof structure; with main timber roof beams and roof purlin members that span horizontally between the main roof beams – refer to **Appendix A ~ Figure No. 8**. Typically, the ends of the timber roof purlins and infill roof beams have tenon cut ends that flush frame into the mortise seat cuts (i.e. notched cuts) that have been cut into the sides of the main roof beams to receive and support the tenoned ends of the purlins and infill roof beams. The tenon ends are typically constructed by a notch being cut into the bottom end of the purlin or infill beam that results in a projecting end on the upper portion of the member end that is inserted into a mortise seat cut that is cut into the sides of the main roof beams. These mortise and tenon type timber framing connections provide flush framed, bearing type, connections between the ends of the roof purlins and infill roof beams and the main roof beams and roof hip beams. In the main hip roof of the main portion of the building there are main timber roof *Hip Beams* at the four (4) hip ridges in the main roof with the bottom ends of the *Hip Roof Beams* bearing on the top of the exterior bearing walls and the top ends terminating at the ends of the main roof ridge beam.

***Figure No. 8 – Typical Timber Roof Framing Configuration of Main Roof Beams and Horizontal Roof Purlins Spanning Between the Roof Beams***
