Town of Holden

Town and School Building Assessments

Various Locations
Holden, MA

F.4 ISSUES PHOTOS CHART

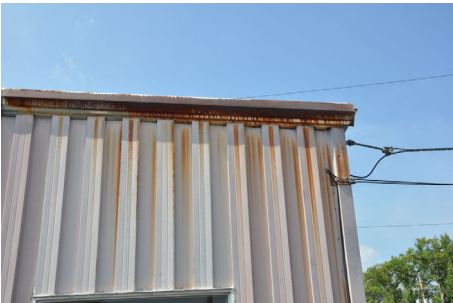
3 **Break Metal Fascia Screws Rusted**
Exterior - The screws holding the break metal fascia in place have rusted.

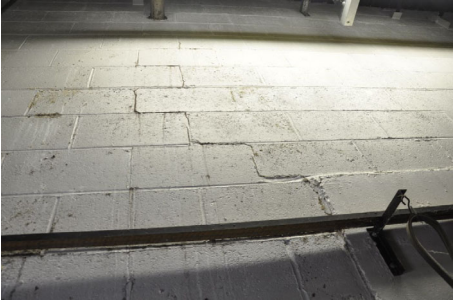
#	Issue	Photos
4	Masonry Crack <i>Exterior, South</i> - There is a crack in the south masonry wall, which is visible both from the interior and the exterior.

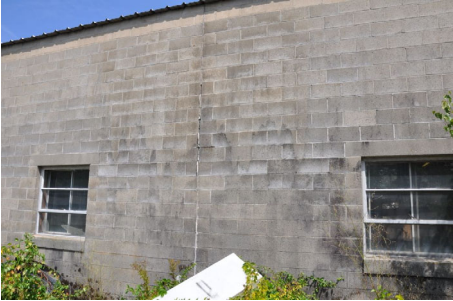
5	No Insulation at Walls <i>Exterior Walls</i> - The exterior CMU wall likely does not have insulation, which may result in undesired temperatures.

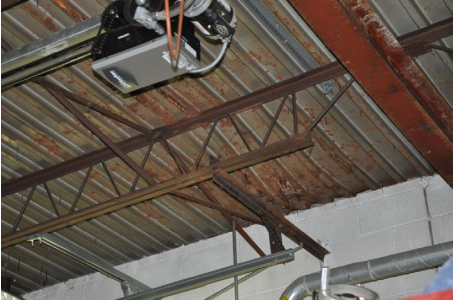
6	Partial Roof Collapse <i>Rear Left of Apparatus Bay</i> - Part of the metal deck and roofing have started to collapse.

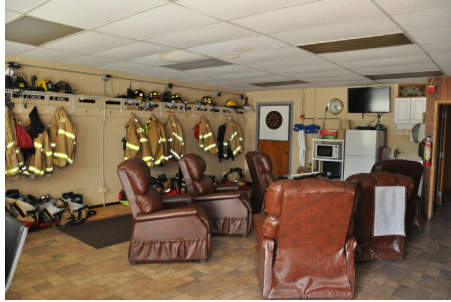
#	Issue	Photos
7	Ceiling Worn <i>Entire Building</i> - The ceiling is showing signs of age.

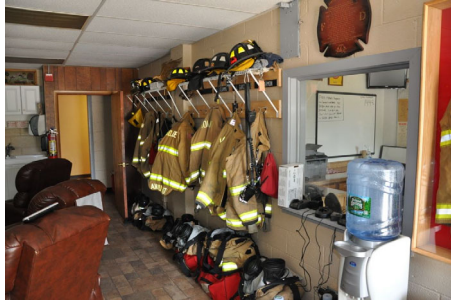
8	Insufficient Lockers (Optional) <i>Dayroom</i> - Fire fighting gear and equipment is stored on hooks in the dayroom and can drip on the walls and floors.

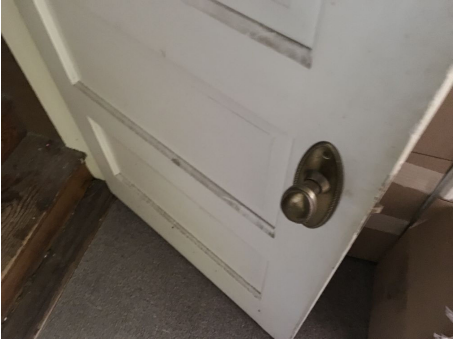
20	Door Hardware Not Accessible (Knobs) <i>Entire Building, mostly Second Floor</i> - Most of the doors have knobs, which are not accessible.

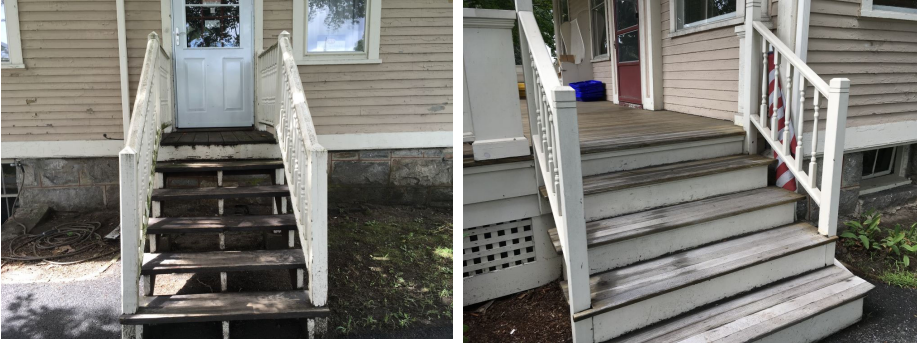
#	Issue	Photos
21	Entry Not Accessible <i>Front and Rear Entry</i> - First Floor has 6 to 9 steps at both the back and the front.

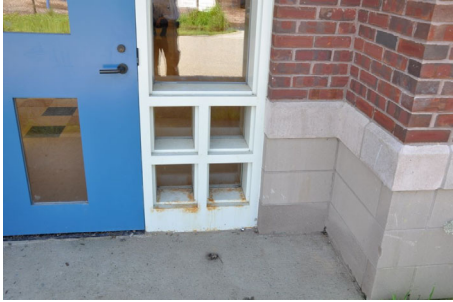
#	Issue	Photos
52	Concrete Stoop and Exterior Door Issue <i>Outside Kindergarten and Rear Gym Exit - Concrete pad at kindergarten room and rear gymnasium exit slopes towards door resulting in leaks into building.</i>

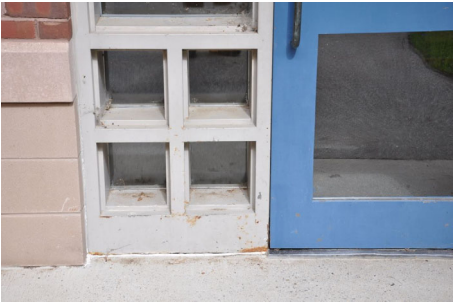
#	Issue	Photos
56	Exterior Door Frames Rusting <i>Various Locations</i> - Exterior door frames are hollow metal (not aluminium) and are showing early signs of rusting.

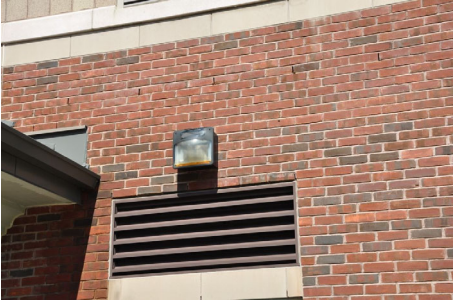
57	Exterior Wall Pack Lights Issues <i>Entire Building</i> - Wall packs in poor condition. Some are full of water; some have been replaced.

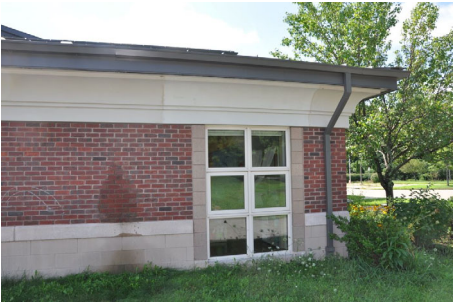
#	Issue	Photos
59	Gutters and Downspouts Seam Issues <i>Entire Building</i> - Gutters are not seamless. They leak at most joints and the connecting rivets and screws are rusting.

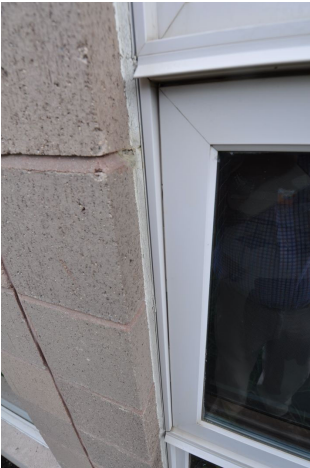
64 **Sealant Aging**
Exterior Windows and Doors, Entire Building - The sealant is aging.

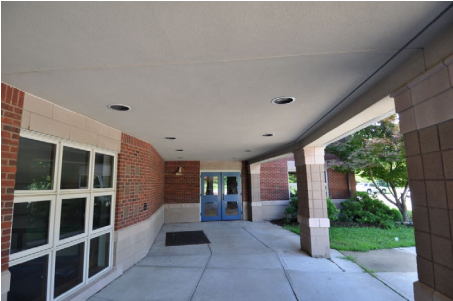
66 **Soffit Panel Joints**
Front Entrance - The joints in the soffit panels are loose and need to be re-secured. Note: this is not significant, however, there could be wind damage.

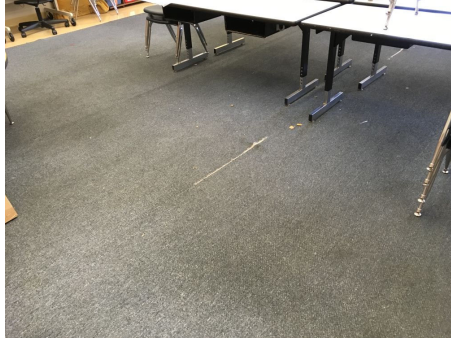
#	Issue	Photos
67	Carpet Wear and Tear <i>Various Locations</i> - The Music Room and various classrooms with large area rugs have carpet that is worn.

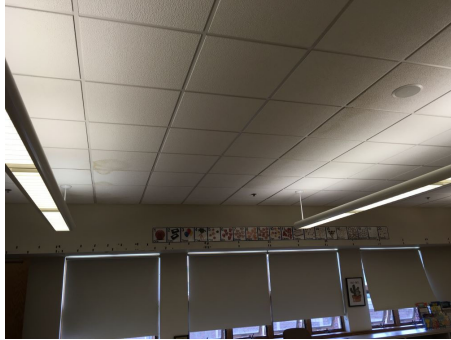
68	Ceiling Tile Damage <i>Entire Building</i> - There is moderate damage to ceiling tile throughout building; mostly chips, some stain.

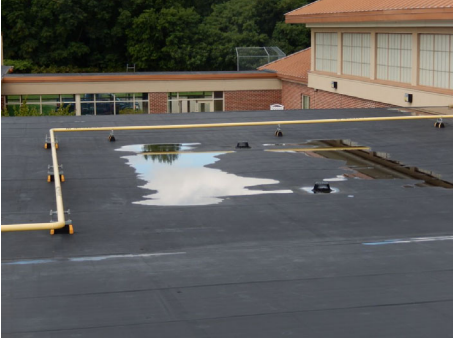
Capital Improvement and Maintenance Plan		
ISSUES PHOTOS		
#	Issue	Photos
111	Roof Age Concern <i>Entire Roof</i> - Many repairs and sealed seams. There are a couple of locations with standing water including over the health room area. Note: the EPDM roof is old, but well maintained.

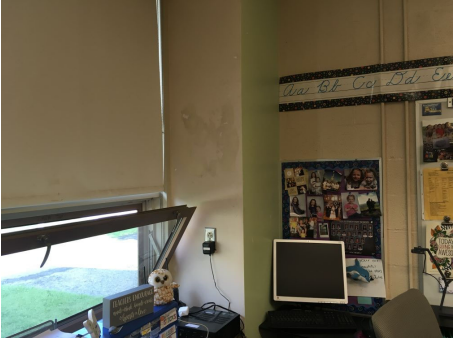
Capital Improvement and Maintenance Plan		
ISSUES PHOTOS		
#	Issue	Photos
119	Paint Damage (Interior) <i>Interior (Entire Building)</i> - The paint is showing typical wear and tear signs of an elementary school

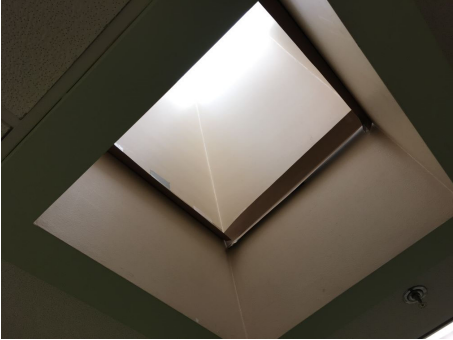
120	Skylight Cardboard Frame <i>Near Entrance</i> - In one of the skylights, there is a cardboard frame taped to the wall. It is not clear what this is for or if there is a problem it is trying to correct.

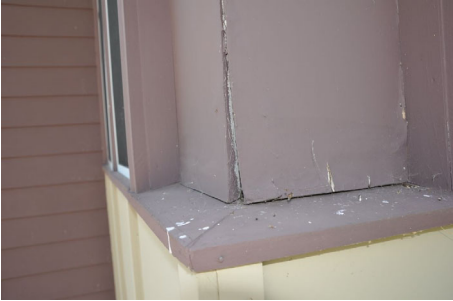
152	Trim Board Condition <i>Main Building</i> - The trim boards may need to be replaced in 5 years.

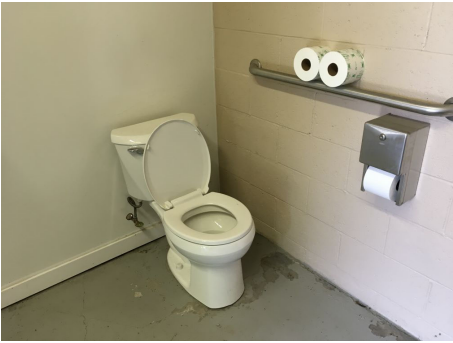
165 **Toilet Not Accessible**
ADA Toilet Room - The toilet in the accessible toilet room is not accessible.

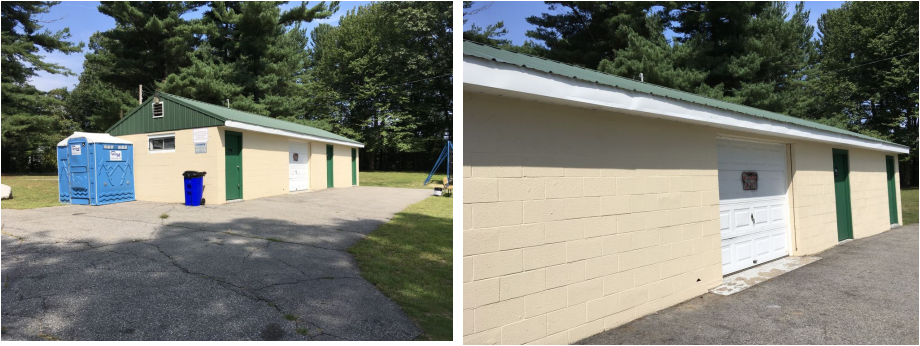
166 **Paint (Exterior and Interior)**
Entire Building - The paint will need to be refreshed within the next 10 years.

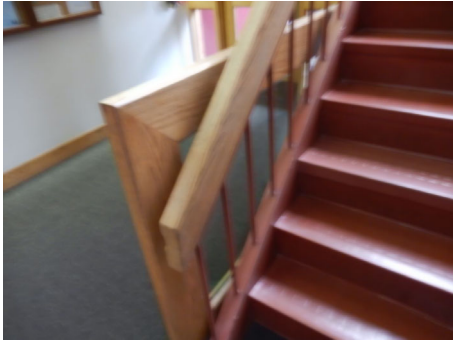
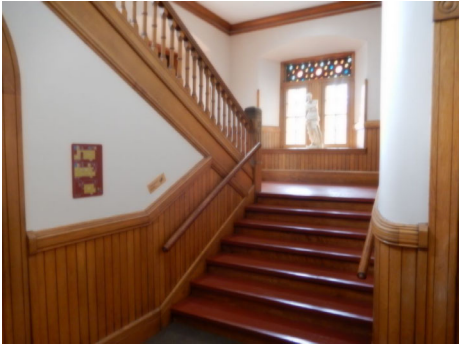
177 **Handrails Not Code Compliant**
Both Stairs - The handrails on both the stairs (one in the newer addition and one in the original building) are not Code compliant.

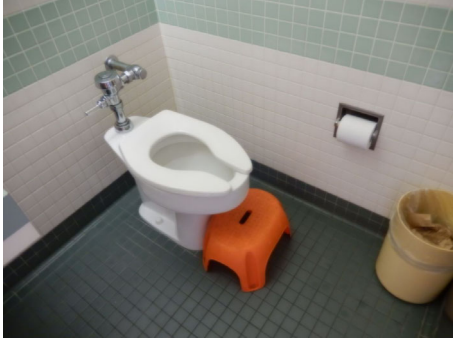
178 **Men's and Women's Rooms Not Accessible**
Third Floor - The rooms are too small to be made accessible to current Codes. But there are accessible toilet rooms on the second floor (has elevator).

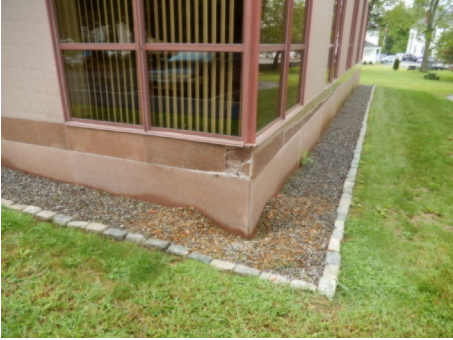
Capital Improvement and Maintenance Plan		
ISSUES PHOTOS		
#	Issue	Photos
179	Broken Stone Panel at North East Corner <i>Building Envelope</i> - Granite panel has been smashed about 2' off the ground. Allows water into building.

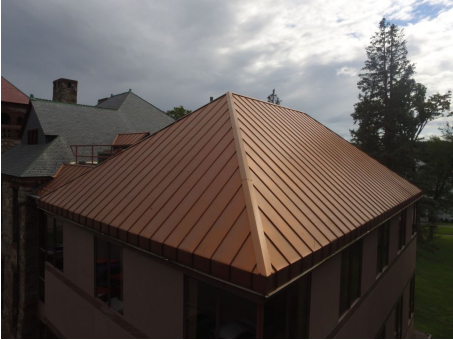
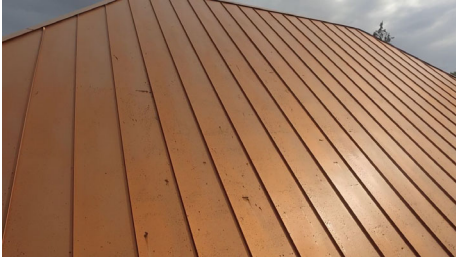
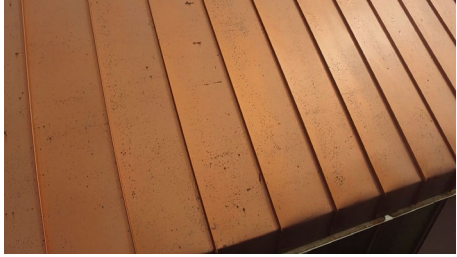
180	Metal Roof Panel Damage <i>Newer Addition</i> - The metal roof panels are pitted and the damaged finish is allowing rusting.

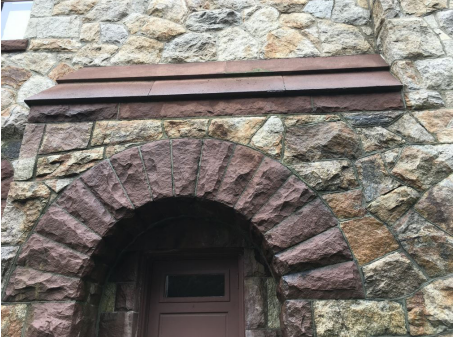
Capital Improvement and Maintenance Plan		
ISSUES PHOTOS		
#	Issue	Photos
181	Minor Mortar Damage <i>Exterior of Old Wing - There is minor mortar damage both in the old and new portions.</i>

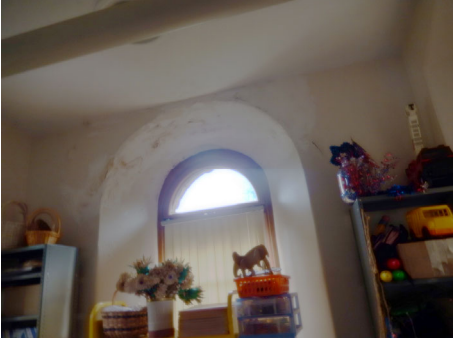
182	Water Damage Over Window <i>Third Floor Tower Room - Plaster arch over a window is stained and peeling.</i>

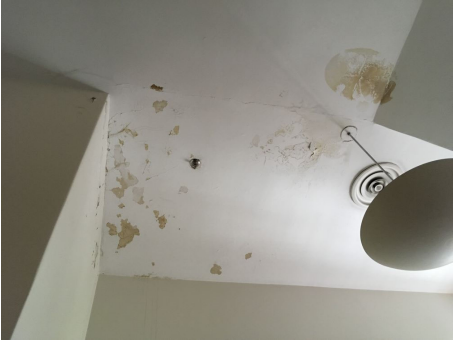
184	Water Infiltration (Children's Dir. Office) <i>Children's Director's Office</i> - The ceiling of the Children's Director's Office has water damage. It is unclear, but could be caused by a roof leak.

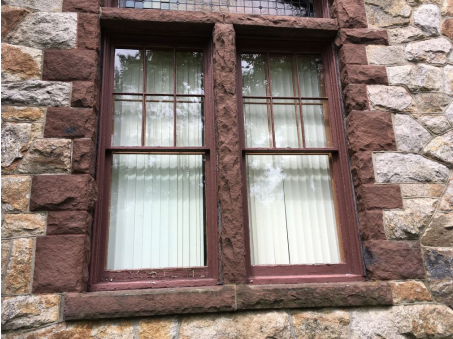
#	Issue	Photos
185	Window Cracked <i>Original Building, 2nd Floor, by Main Entry - One of the windows in the original building adjacent to the newer addition by the main entrance is cracked.</i>	 
186	Wood Windows Need Paint <i>Exterior of Old Wing - The paint on the wood windows in the original building has worn.</i>

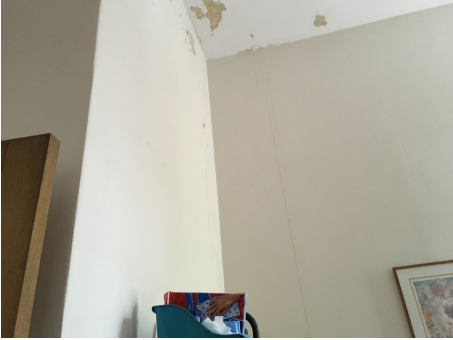
Capital Improvement and Maintenance Plan		
ISSUES PHOTOS		
#	Issue	Photos
190	Multiple Plaster Cracks <i>Interior, Multiple Locations</i> - There are multiple cracks in the plaster in the old building.

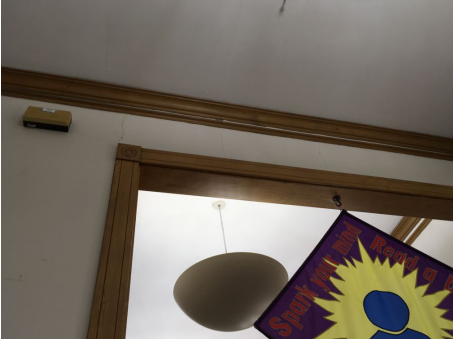
191	Paint Damage (Interior) <i>Various Locations</i> - The paint is damaged in various locations.

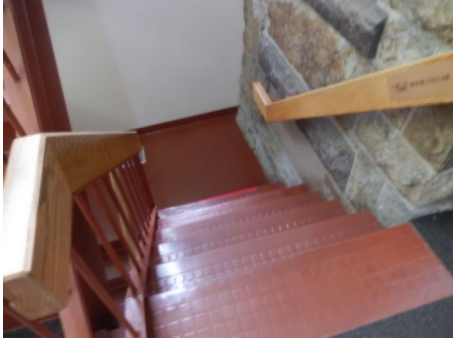
#	Issue	Photos
192	Rubber Stair Treads Lifting <i>Main Stair</i> - The rubber treads on the stair are detaching.

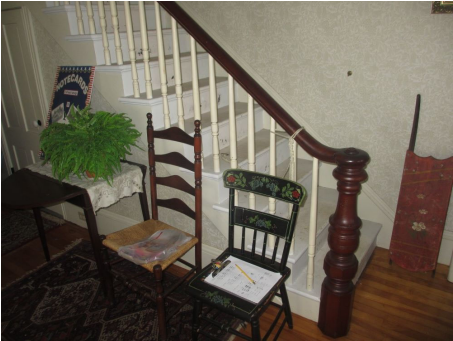
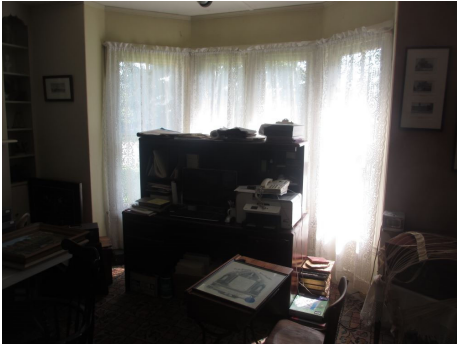
208 **Aged Paint**
Entire Building - Interior paint on walls and ceiling is old. Note: many walls have wallpaper. Painted surfaces include limited walls, ceiling, stairs, handrails, etc.

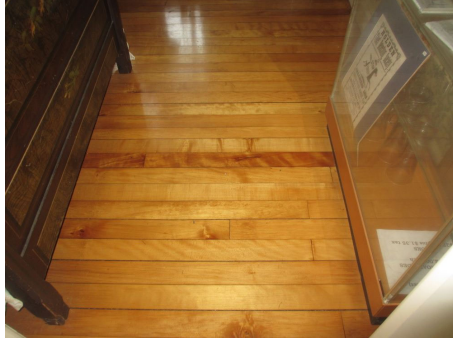
#	Issue	Photos
209	Worn Floors <i>Entire Building</i> - Hardwood floors are old and covered with carpet.

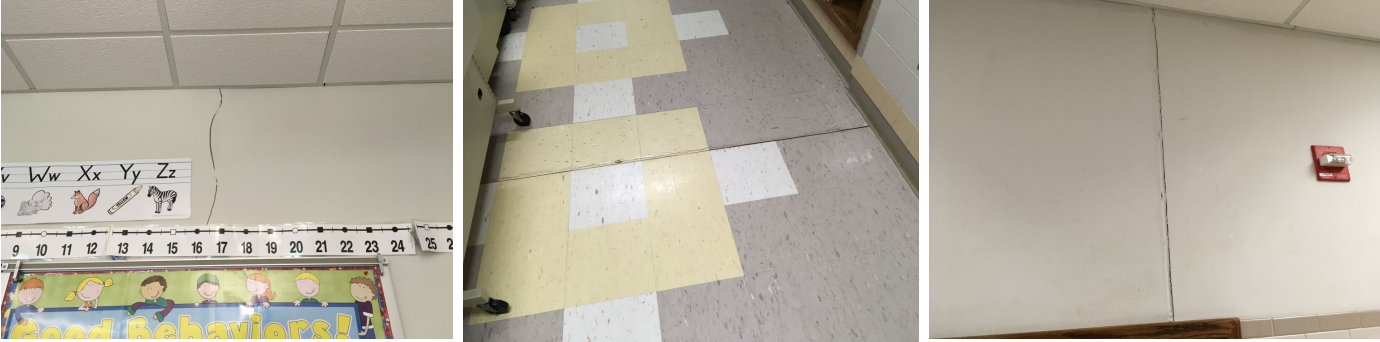
#	Issue	Photos
238	Cracks in Wall, Flooring, and Hard Clings <i>South Portion</i> - There are a number of cracks in the gyp. board walls, VCT flooring, and hard ceilings, which were likely caused by the building settling.

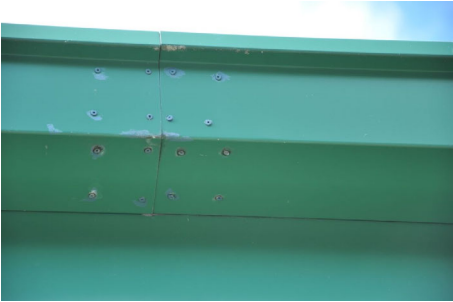
<p>The photo shows a close-up of a gutter joint on the east facade of the building, with water visible leaking from the joint.</p>
240	Gutter Rivets Rusted <i>North Facade</i> - Rivets in gutters appear rusted.

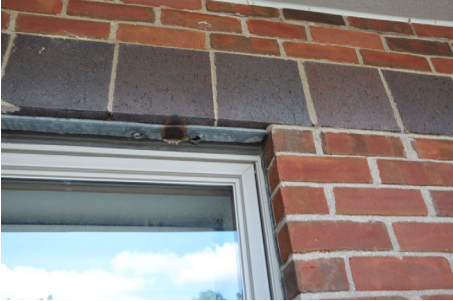
#	Issue	Photos
241	Lintels Rusted <i>East Facade</i> - At two locations, one at a window and one at the main overhang, the lintel is rusted.

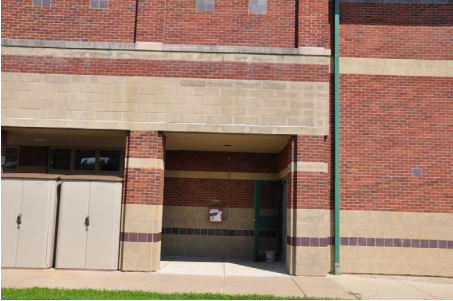
242	Masonry Efflorescence <i>West Facade</i> - Water getting into the masonry wall, getting trapped, and while slowly evaporating, is bringing the efflorescence to the surface. At this time, the total amount of efflorescence is minimal, but the cause should be investigated.

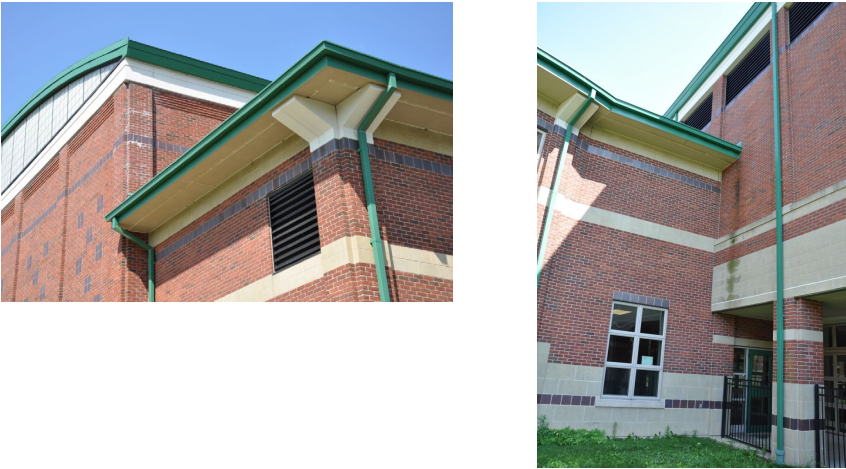
#	Issue	Photos
243	Masonry Water Infiltration and Roof Issue <i>Southwest and Northeast Corner of Gym - At both the southwest and northeast corners of the gym, there are adjacent roofs where water flows over roof edge causing damage to the masonry below.</i>

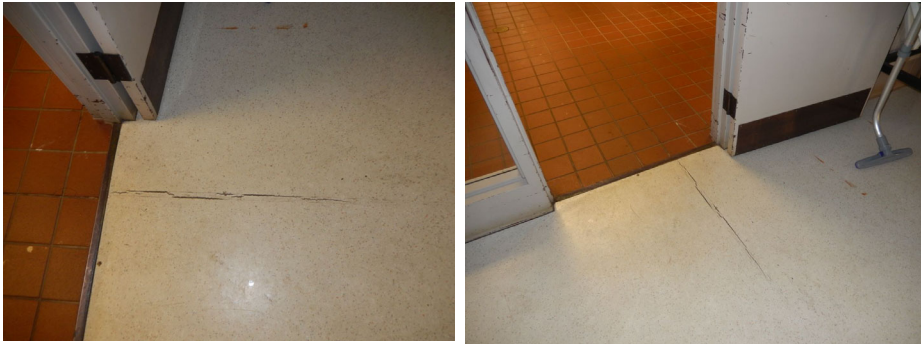
#	Issue	Photos
248	Window Sashes Damaged <i>West Facade</i> - Two damaged window sashes.	
249	Crack in Sheet Vinyl and Quarry Tile Floors <i>Cafeteria and Kitchen</i> - The slabs have settled and the high point is a crack that runs 4-5 feet in the cafeteria and 4-5 feet into the kitchen.

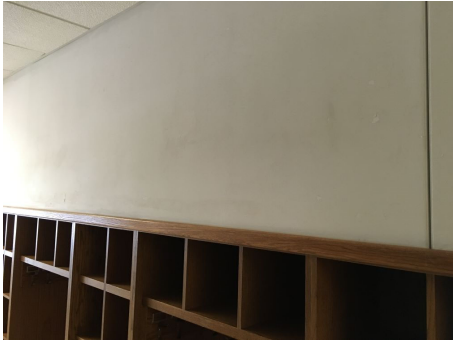
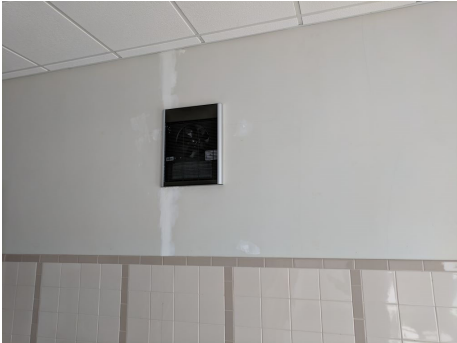
253 **Paint Damage (Interior)**
Entire Building - The walls show wear and tear. For example, it appears that tape was used in multiple locations, and when it was removed, it ripped the paint.

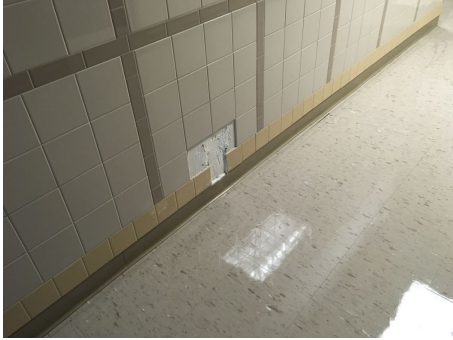
#	Issue	Photos
255	Wall Tile Missing <i>Outside Room 276 - A few wall tile are missing.</i>

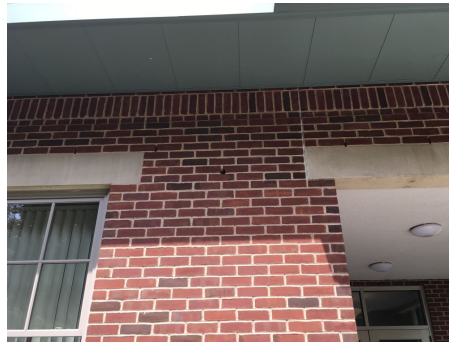
286 **Brick and Mortar Damage**

Brick Exterior - Couple of holes and missing mortar

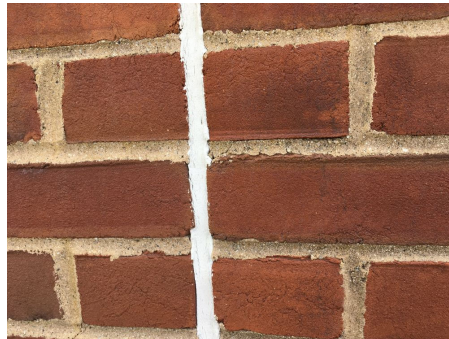
287 **Sealant Cracked**

Brick Exterior - Sealant at expansion joint is starting to crack.

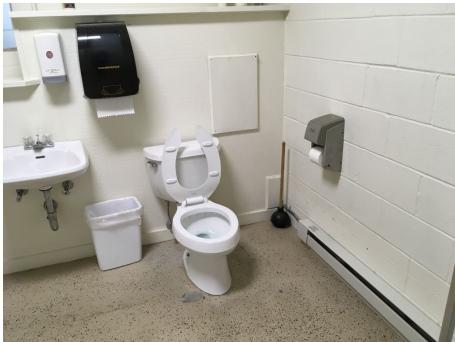
329 **Bathroom Not Accessible**
Basement Bathroom - The basement bathroom is not accessible. This include the toilet, sink, and shower.

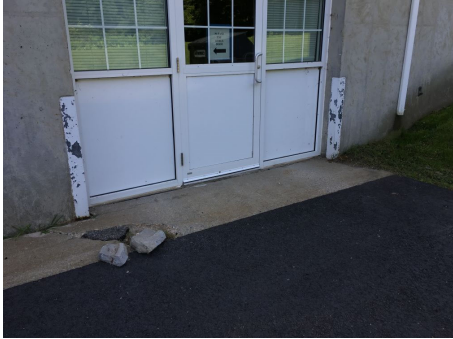
#	Issue	Photos
330	Corner Guards Peeling <i>Exterior doors</i> - The paint on steel corner guards at the former garage doors (current windows and panels) are starting to peel.

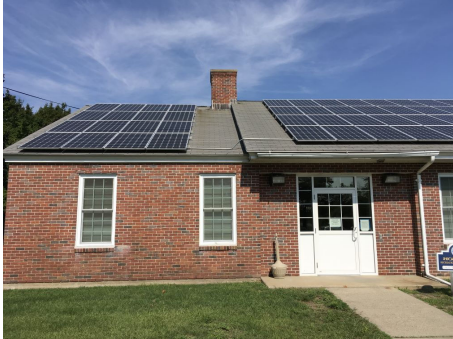
331	Gutter Damaged <i>Roof</i> - Sliding snow has damaged the gutter.

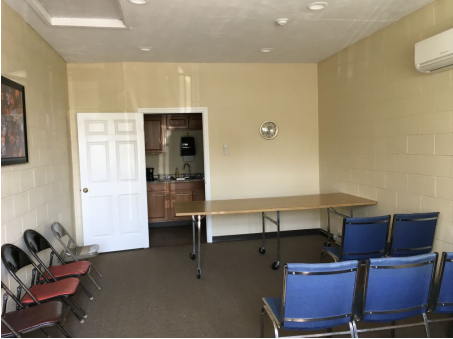
#	Issue	Photos
333	Carpet Worn (Meeting Room) <i>Meeting Room</i> - The carpet is worn.

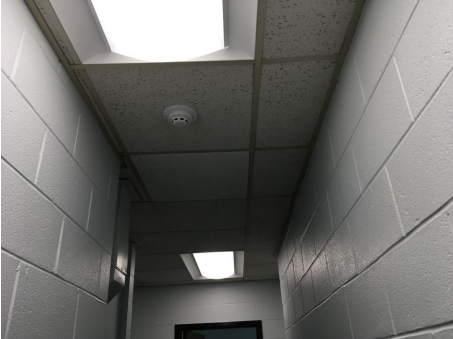
334	Ceiling Grid Dirty and Discolored <i>Corridors offices and toilet rooms</i> - The ceiling grid appears to be stained.

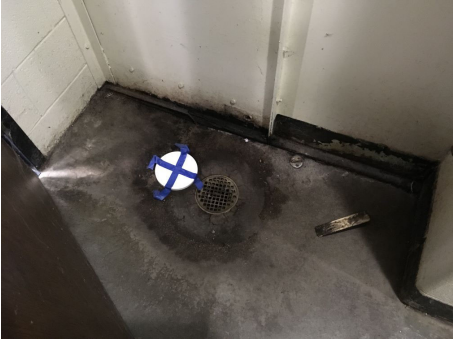
#	Issue	Photos
335	Cell Wall and Floor Damage <i>Former cells</i> - Holes in CMU walls and damage to concrete floor near floor drains.

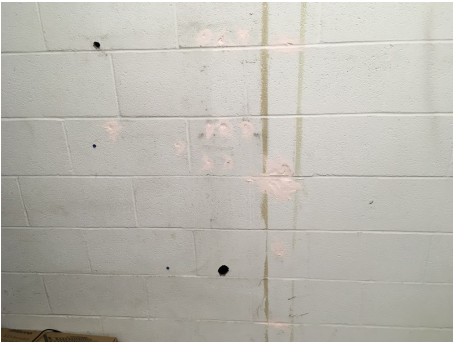
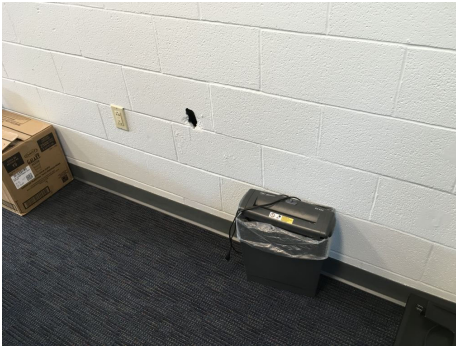
336	CMU Wall Holes <i>Various Locations</i> - There are various holes in the CMU throughout the building, which may have been from former equipment. For example, the Server Room has several holes.

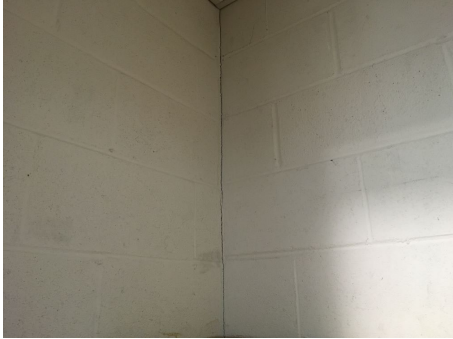
#	Issue	Photos
337	Masonry Wall Crack <i>Front left second office</i> - There is a crack in the walls where they intersect at a corner.

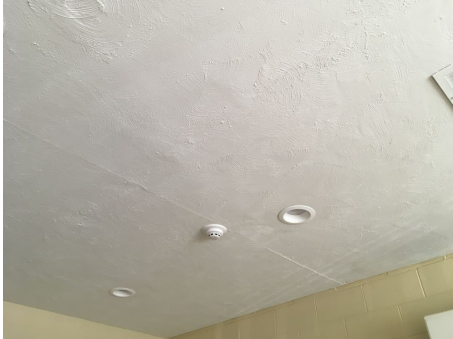
338	Minors Cracks in Ceiling (Meeting Room) <i>Meeting Room</i> - There are minor cracks in the plaster ceiling in the Meeting Room.

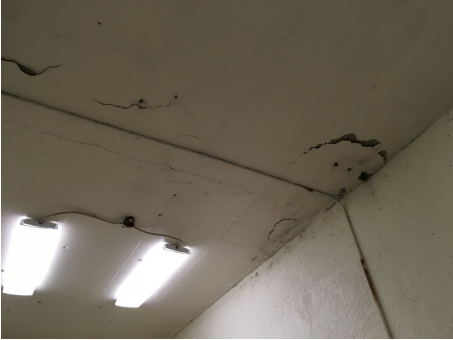
#	Issue	Photos
339	Paint Damage (Interior, Basement) *1 <i>Basement</i> - The basement walls need to be repainted.

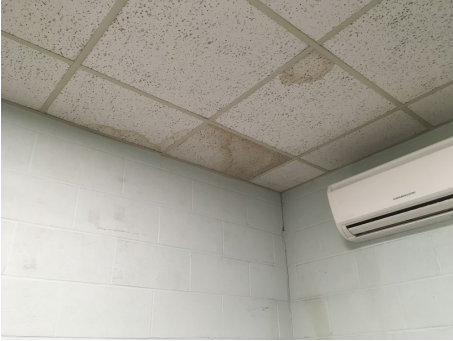
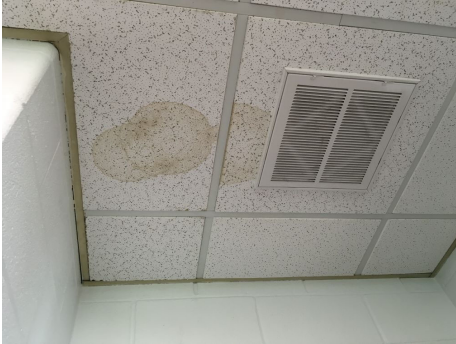
340	Stained Ceilings (Various Locations) <i>Various Locations</i> - In multiple locations on the second floor, there are water stained ceiling tiles. It is not clear if this is from a roof leak or from attic equipment issues.

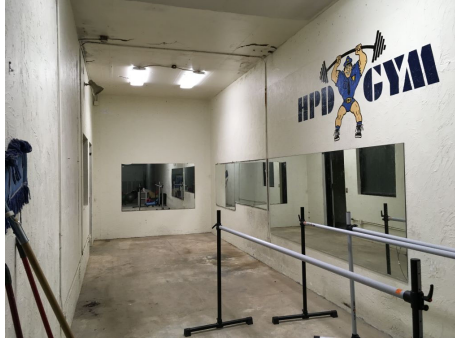
#	Issue	Photos
344	Basement Ventilation Issues*1 <i>Basement</i> - The basement is unused except for one space used as a studio. The basement is musty and lacks ventilation.

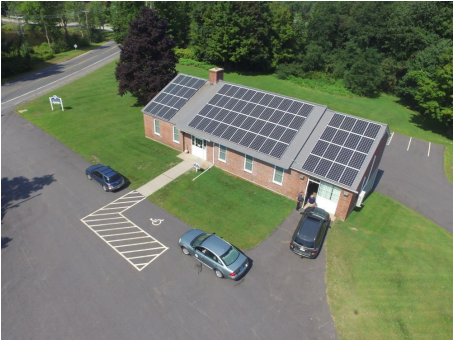
#	Issue	Photos
354	Interior Lighting <i>Entire Building</i> - Lighting consists of incandescent, and fluorescent fixtures throughout the building and LED fixtures in the offices on the main floor recently renovated.	
355	Light Not Working*1 <i>Basement Electrical Room</i> - A light in the basement electrical room does not work.	
356	Photovoltaic System <i>Roof</i> - Building is provide with a Photovoltaic array on roof

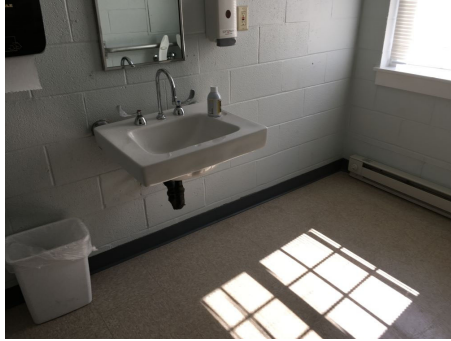
#	Issue	Photos
357	Piping Insulation Missing <i>Main floor bathrooms - No insulation under ADA lavs.</i>

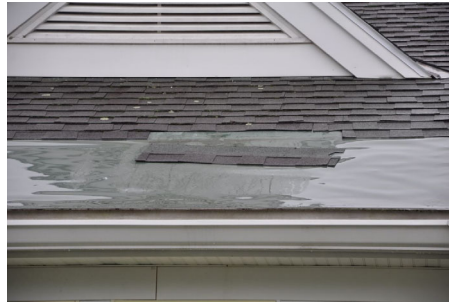
361 **Asphalt Shingles Loose**

Roof, left of entry - A few shingles have gotten loose and are out of place.

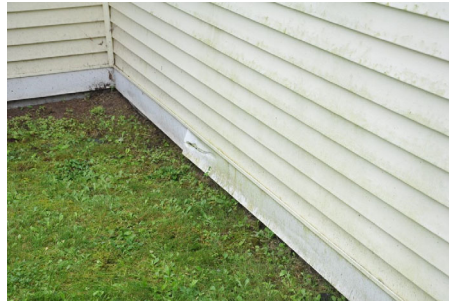
362 **Base Trim Damaged**

South Side - A small portion of the base trim on the exterior of the building along the south side appears to be damaged.

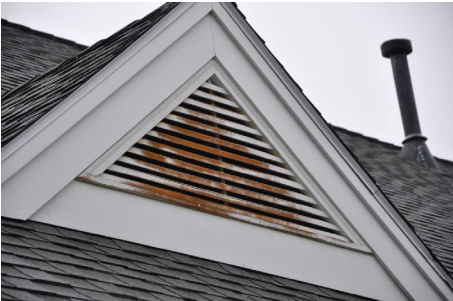
#	Issue	Photos
365	Missing Ridge Vent Part <i>Roof left of entrance - Part of ridge vent missing.</i>	
366	Paint Damage (Exterior) <i>South side - MDF louvers, trellis, and column bases need paint.</i>

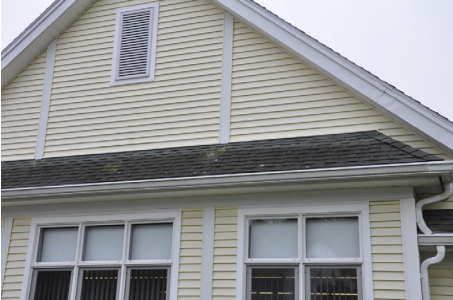
367	Roof Organic Growth <i>Low roof to right of entry - Organic material growing on the roof.</i>

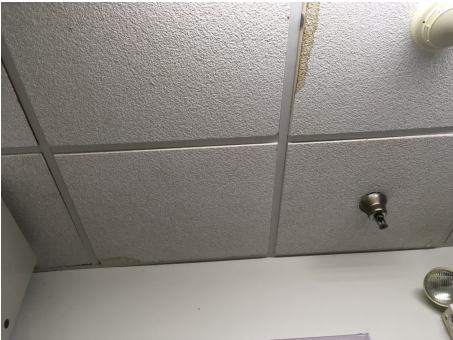
#	Issue	Photos
368	Water Damage (Interior, Back Right) <i>Office in back - Stains on ceiling tile.</i>

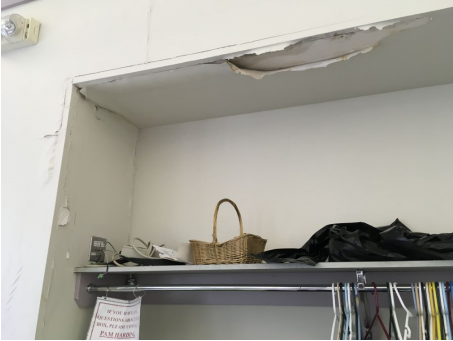
369	Water Damage (Interior, Front) <i>Vestibule, adjacent Tlt Rm, & MPR - There is water damage at the ceiling and walls in the vestibule, adjacent single user toilet room, and multipurpose room. Most likely, this is the result of a roof leak in the area.</i>

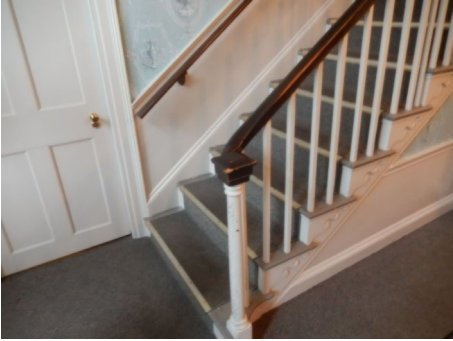
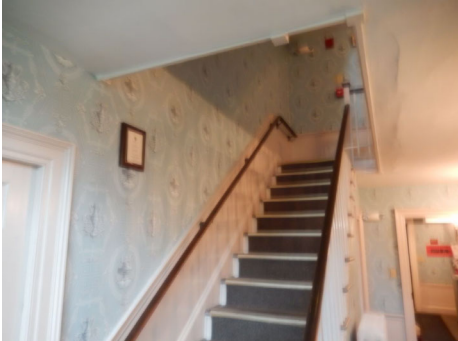
387	Door Hardware Not Accessible <i>First and Second Floors</i> - Door hardware consists of round door knobs. Lever handles are required.	
388	Handrails Not Compliant <i>Stairs</i> - The stair handrails do not meet code for a variety of reasons: no extension, no wall baluster, etc.

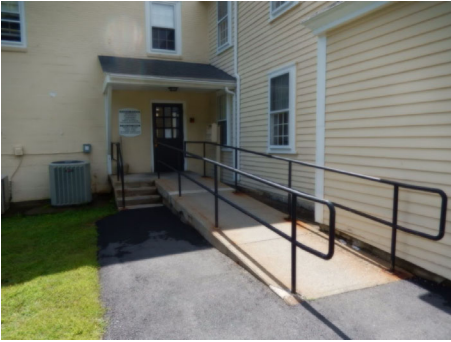
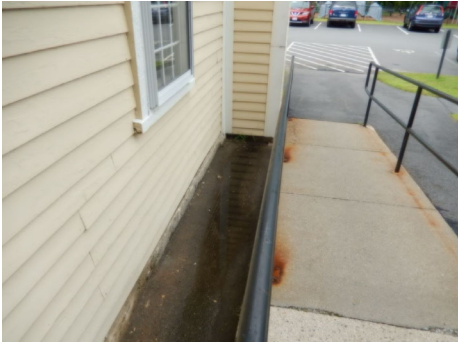
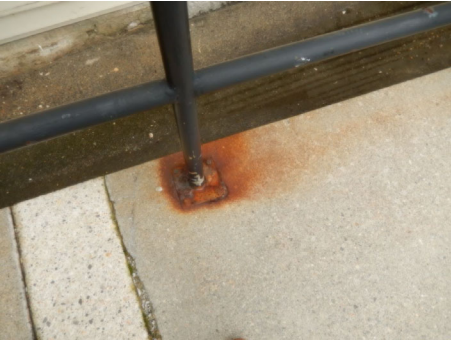
#	Issue	Photos
389	No Accessible Toilet Rooms <i>First and Second Floors</i> - There are no toilet rooms on the first floor and the toilet rooms on the second floor are not accessible.	
390	No Braille Signage <i>First and Second Floors</i> - There is no signage that includes Braille for the rooms at Starbard.	
391	Ramp Not Compliant <i>Exterior HC Ramp</i> - The concrete ramp and stair are in poor condition resulting in them no longer being in compliance. Also, the handrails do not meet code.

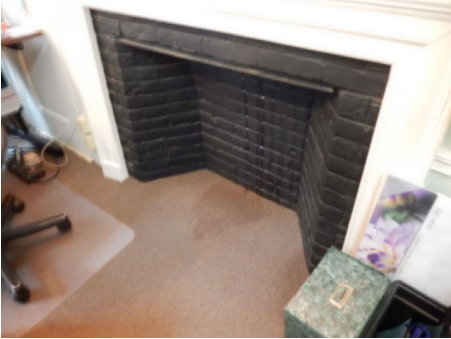
#	Issue	Photos
394	Chimney Leak <i>Assessor's Office</i> - Rain water drips into fireplace from above.

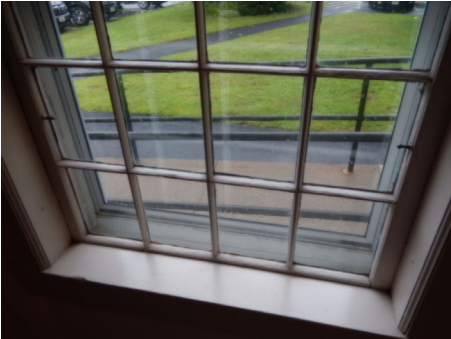
395	Wood Windows Fair to Poor Condition <i>Entire Building</i> - Single glazed wood windows glazing compound and paint are failing off.

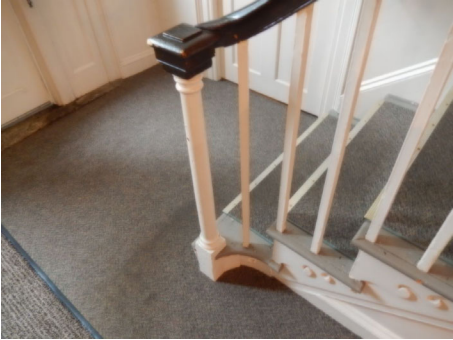
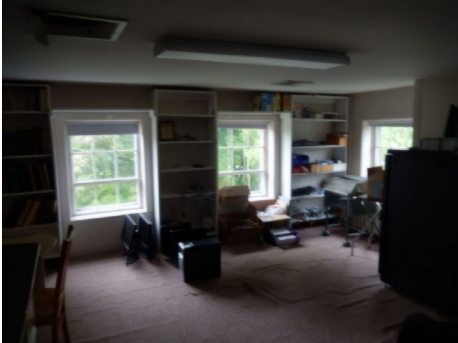
#	Issue	Photos
396	Carpet in Poor Condition <i>Entire Building</i> - Carpet is worn in the Hallways. Carpet in Selectman's room and offices is in good condition.

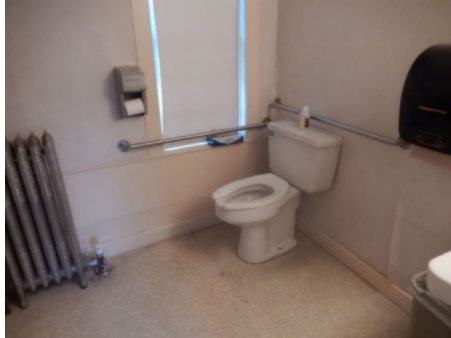
#	Issue	Photos
398	Toilet Room Finishes in Poor Condition <i>Men's and Women's Rooms - Floors and walls need to be refinished.</i>

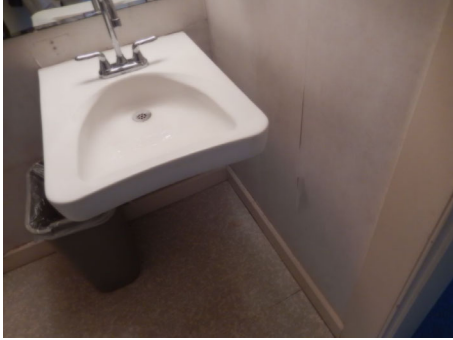
#	Issue	Photos
415	Lavatory Piping Not Insulated <i>Bathrooms</i> - There is no insulation on the piping under the ADA compliant Lavs.

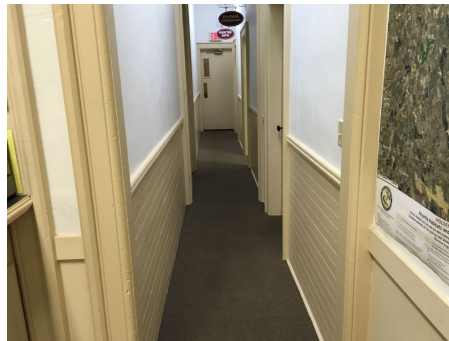
423 **Corridor Too Narrow (Accessibility)**

First Floor Corridor - The corridor on the first floor is too narrow. This also impacts the door at the end of the corridor, which does not have the required door clearances.

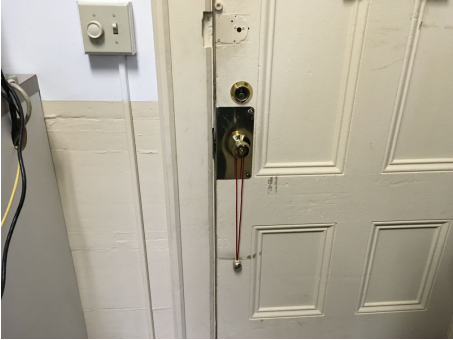
#	Issue	Photos
424	Door Hardware Accessibility Concerns <i>Entire Building</i> - Doors to interior closets and behind public counters have door knobs. If these areas remain employee-only, there are no issues. If the public needs to use one of these doors, the hardware will need to be changed.

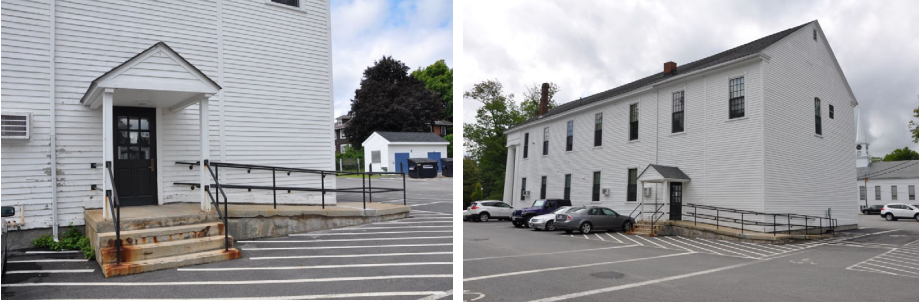
425	Railings Not Compliant (Ramp) <i>East Side</i> - Ramp railings do not comply with IBC & MAAB. See also "Railings Not Compliant (Rear Steps)".

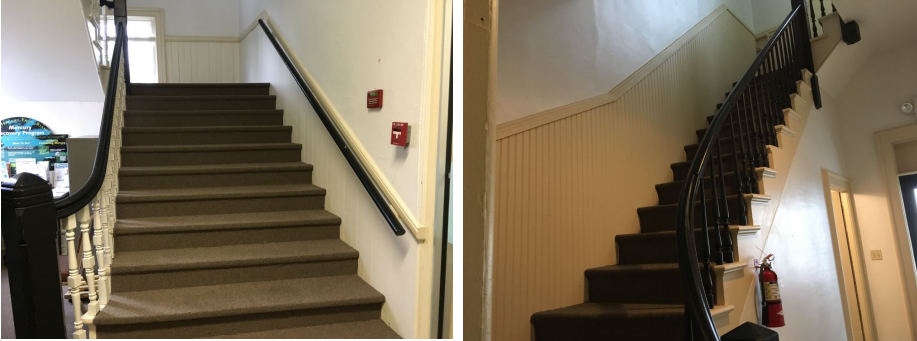
#	Issue	Photos
426	Railings Not Compliant (Rear Steps) <i>East, Rear Entrance</i> - The handrails on the front and back stairs are not Building Code compliant (i.e. too low). See also "Railings Not Compliant (Ramp)".

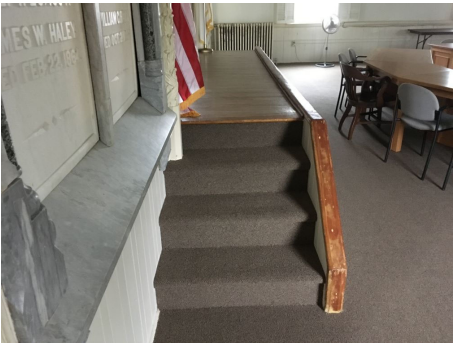
427	Stage Not Accessible <i>Second Floor Meeting Room Stage</i> - The stage in the large second floor meeting room can only be reached by stairs and is therefore not accessible. It does not appear that the stage is used by the public.

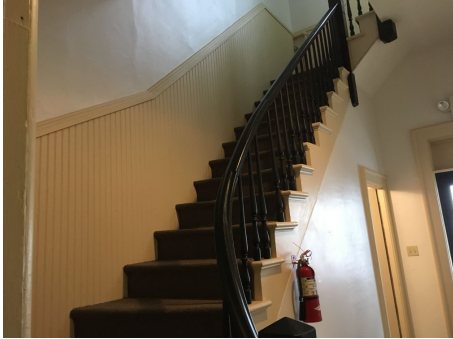
#	Issue	Photos
428	Stairs Not Accessible <i>Front and Back of Building</i> - Both the front and back stairs have accessibility issues (i.e. handrails). However, there is an elevator. It is assumed these stairs previously received a variance.

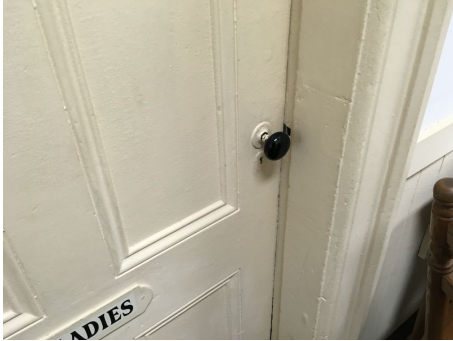
429	Toilet Rooms Not Accessible <i>First Floor Men's and Women's Toilet Rooms</i> - Both first floor Men's and Women's Toilet Rooms are not accessible: door knobs, flush valve on the wrong side, toilet paper dispenser too high, etc.

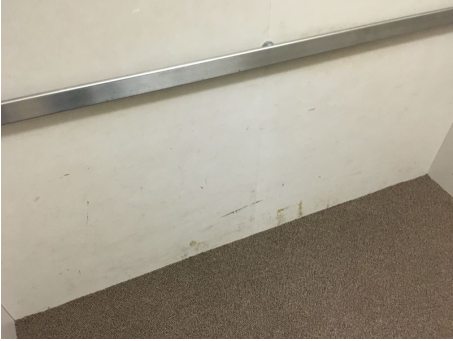
#	Issue	Photos
430	Elevator Wall Damage <i>Elevator</i> - The walls of the elevator are slightly damaged from scuffs and minor dents.

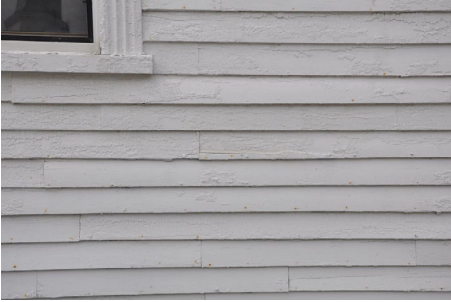
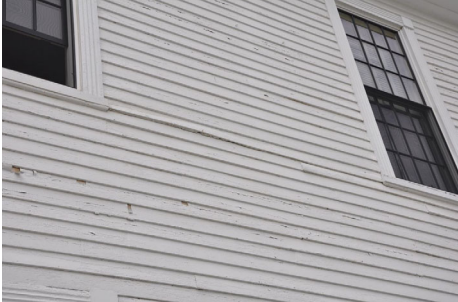
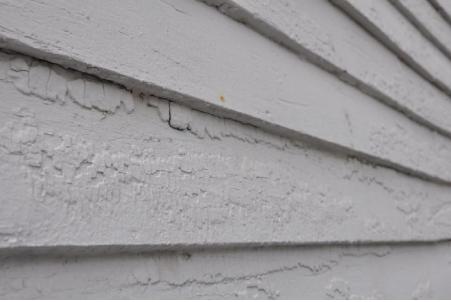
#	Issue	Photos
433	Exterior Siding and Trim Paint Damage <i>Entire</i> - The exterior is wood siding and trim. Other than the newer elevator addition on the rear of the building, the exterior needs to be stripped of all paint and repainted. This includes siding, window trim and front columns. See also "Exterior Siding and Trim Wood Damage".

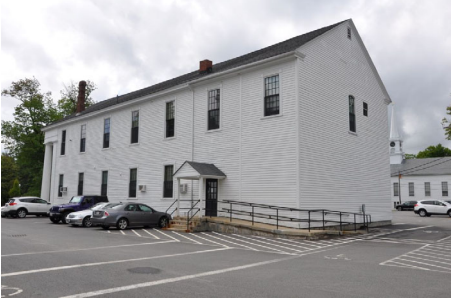
434	Exterior Siding and Trim Wood Damage <i>Entire</i> - Approximately 20% of the exterior siding needs to be replaced, in selected random locations. See also "Exterior Siding and Trim Paint Damage".

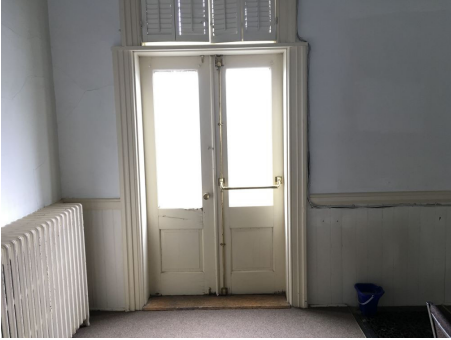
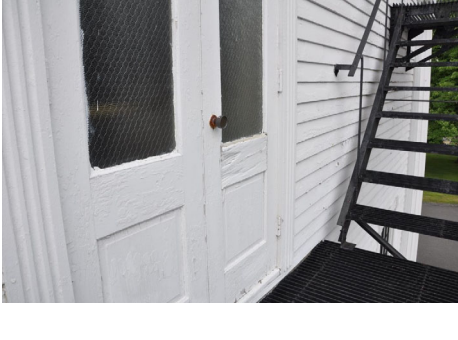
435	Fire Escape Doors (Meeting Room) <i>West Side Fire escape</i> - Both egress doors of the double doors are in poor condition. Additionally, neither are the minimum width.

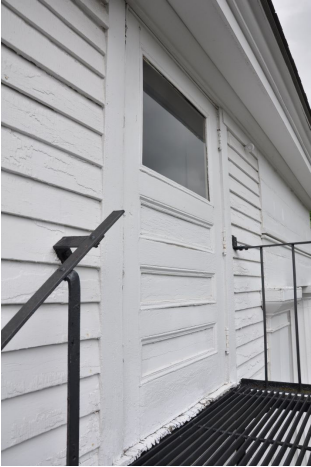
#	Issue	Photos
436	Fire Escape Doors (Stair to Balcony) <i>Top of Fire Escape</i> - The exterior door from the balcony stair landing onto the fire escape is deteriorated. Also, there is no door threshold, which is allowing water infiltration on the floor and in wall.

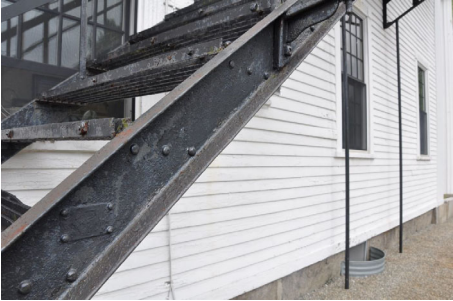
437	Fire Escape Issues <i>West Side, Exterior</i> - The fire escape appears structurally sound, but the paint is in poor condition. Based on today's standards the treads, risers and railings are substandard and are probably considered dangerous.

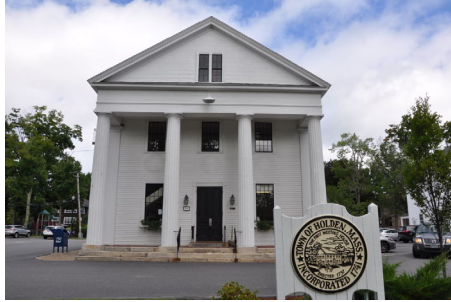
#	Issue	Photos
438	Front Entrance Not Accessible <i>Front Entrance Doors</i> - The front entrance doors are not accessible; each leaf is 2'4"; lacks compliant hardware; consists of steps; etc.. It should be noted that an accessible entrance is to the rear left side, and there is signage directing the public to it.

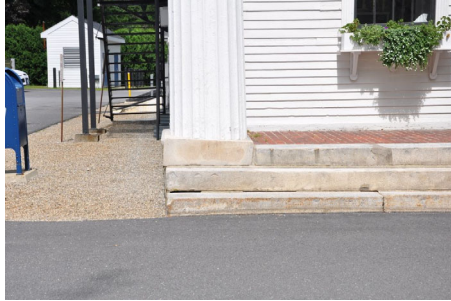
439	Front Stair Issues (Exterior) <i>Front Exterior Stairs</i> - The mortar joints in the front granite stairs have failed. Additionally, the steps are not equal, which is a violation of the Building Code.

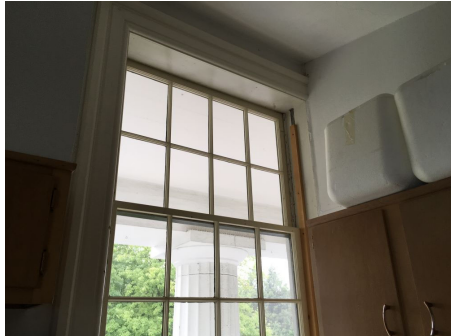
440	Kitchen Window Adjustment <i>Kitchen, Second Floor, Front Facade</i> - The front facing kitchen window has a piece of wood covering a part of the jamb. This is one of the restored windows, and it's unclear what the wood is doing.

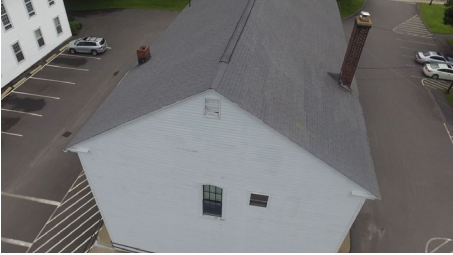
#	Issue	Photos
441	Louver Damaged <i>North Side Elevation (rear)</i> - The wood louver is deteriorated and probably allowing water to enter the building

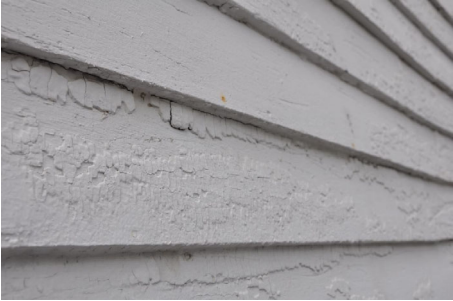
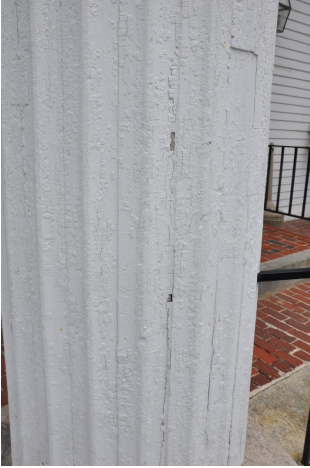
442	Paint Deterioration (Exterior) <i>Exterior</i> - The exterior paint is peeling and it is evident there have already been too many layers of paint. This includes siding, trim, and the columns in front.

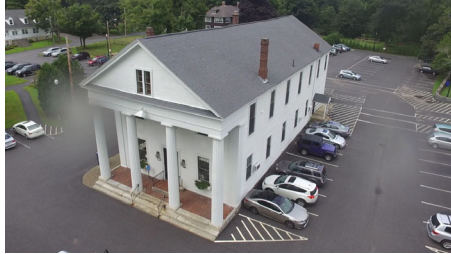
#	Issue	Photos
443	Roofing Deterioration <i>Entire Building</i> - Roof shingles appear to be in early stage of deterioration. This needs to be confirmed.

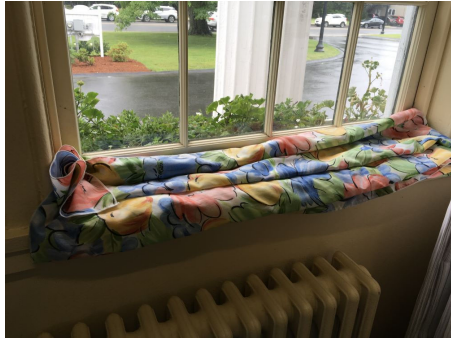
444	Standing Water on Concrete and Dirt Floor <i>Basement Floor</i> - In the basement, there is no slab; the floor is a dirt floor. There are several pools of standing water. It was reported that while the sump pump was off, some flooding occurred, but it is questionable if this is the cause of the current water on the floor.	
445	Window Draft <i>Front of Building</i> - The windows on the front of the building appear to be restored original windows with single panes of glass. Users reported drafts, which may be from being single pane units. Options are limited if the goal is to keep the historic windows.

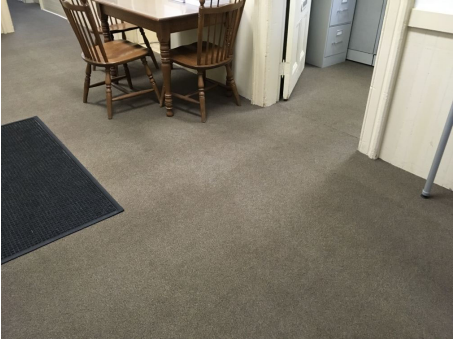
#	Issue	Photos
446	Basement Stairs Not Compliant <i>Basement</i> - The stairs to the basement are not building Code compliant. The tread size varies, and there are no risers.	
447	Carpet Worn <i>Entire Building</i> - The carpet is showing signs of wear and tear.

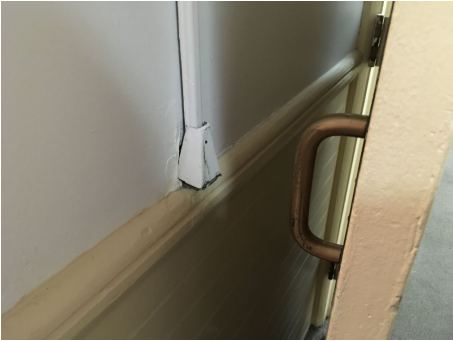
448	First Floor Corridor Door Issues <i>At the back of the First Floor Corridor</i> - Two issues with the door at the end of the first floor corridor: the door sticks, and when open, the door handle damages some conduit on the wall.

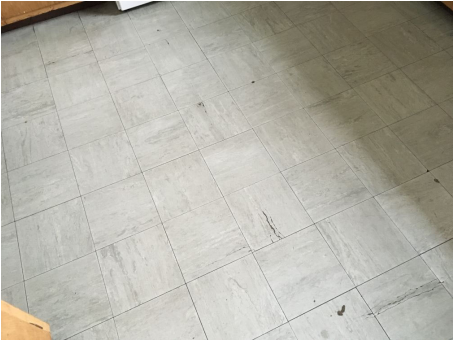
450 **Flooring Material Concern**
Kitchen - The kitchen on the second floor has 9X9 floor tile that may contain asbestos. There are a few cracks, but overall, they are in fair shape and could last more than 10 years.
