Town of Holden

Town and School Building Assessments

Various Locations
Holden, MA

F.4 ISSUES PHOTOS CHART

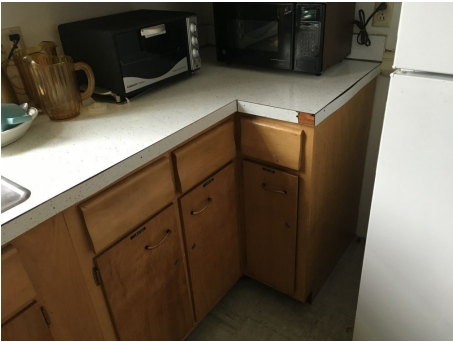
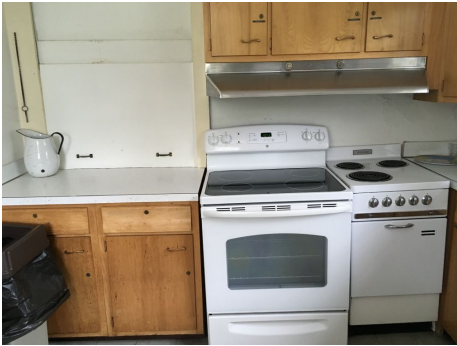
451 **Kitchen Cabinets and Countertop Worn**
Kitchen, Second Floor - The kitchen cabinets and countertops are old and worn. For cosmetic reasons, these could be replaced.

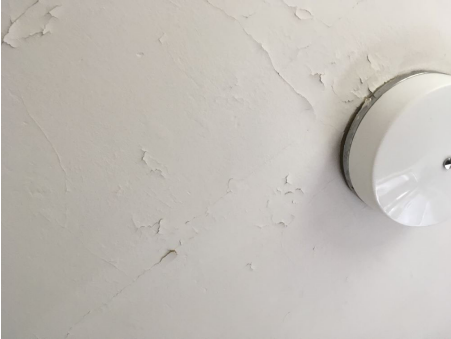
Capital Improvement and Maintenance Plan		
ISSUES PHOTOS		
#	Issue	Photos
452	Kitchen Ceiling Peeling <i>Kitchen, Second Floor</i> - The ceiling in the kitchen is peeling, possibly from moisture. Although the room has an exhaust hood over the stove, there is no general exhaust.

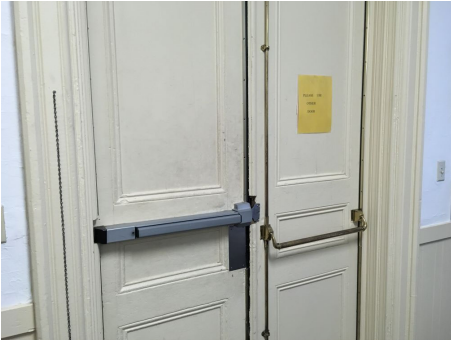
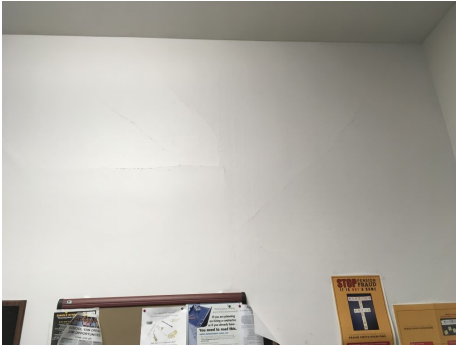
453	Paint Deterioration (Interior) <i>Entire Building</i> - Paint throughout the building is scuffed and worn. Also, some shrinkage cracks have appeared in the gypsum board. This also affects the stairs leading from the second floor to the meeting room balcony.	<div>

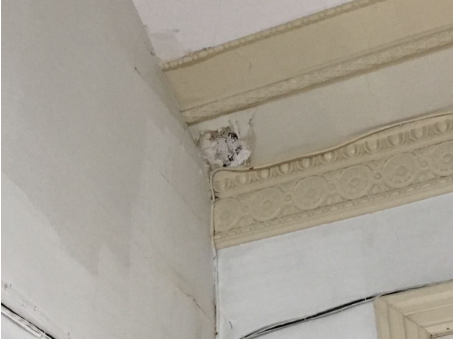
#	Issue	Photos
454	Plaster Ceiling Damage <i>Second Floor Meeting Room</i> - A couple of areas of the plaster ceiling in the second floor meeting room have fallen.

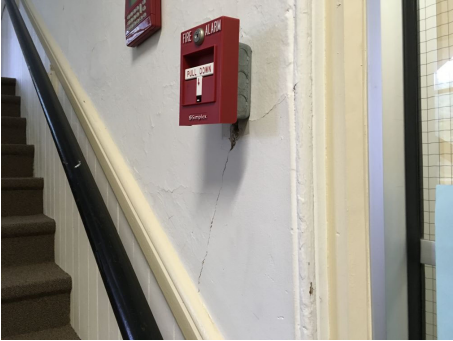
455	Wall Damage at FA Device <i>Front Entrance Vestibule/Stair</i> - Some of the plaster in the front entrance vestibule / stair was damaged while a pull station was installed.

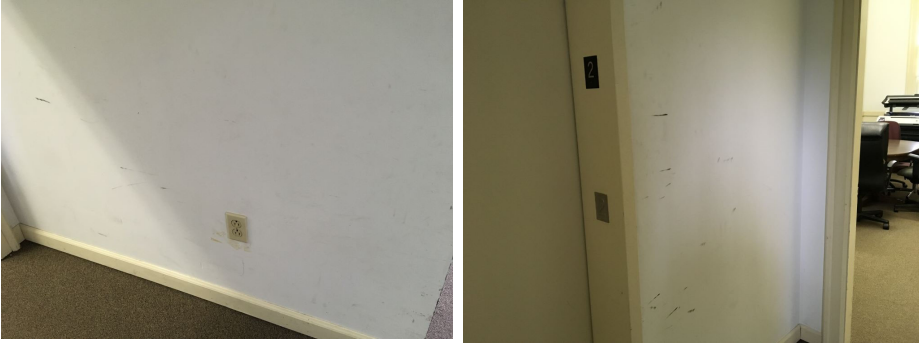
#	Issue	Photos
456	Wall Damage at Second Fl. Elevator Lobby <i>Second Floor Elevator Lobby</i> - The walls outside the elevator on the second floor are scuffed and marked.

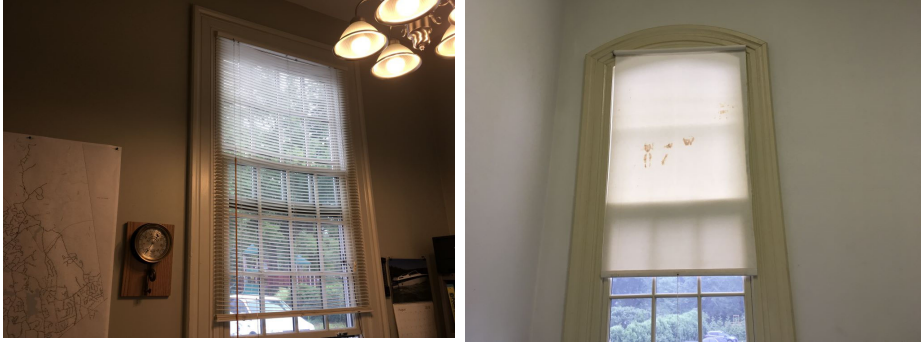
#	Issue	Photos
458	Window Treatment Damage <i>Various Locations</i> - Some of the blinds and shades have minor damage.

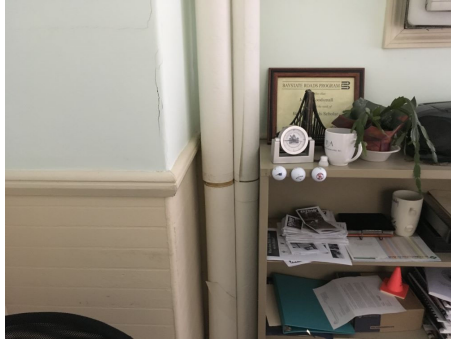
#	Issue	Photos
468	Insulation Detaching <i>Various Locations</i> - In some locations, the insulation around piping has become loose and is coming off.

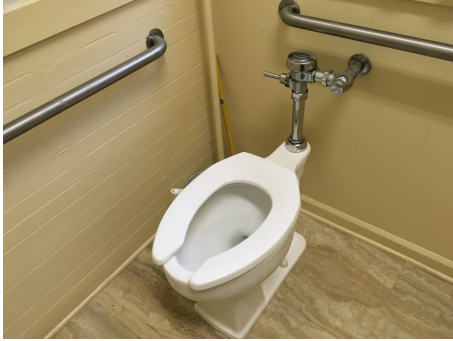
#	Issue	Photos
473	Paint Damage (Interior, Radiators) <i>Entire Building</i> - The gloss paint on the radiators do not appear to have withstood the expansion and contraction.	
474	Plumbing Fixtures Dated and Damaged <i>Bathrooms</i> - The bathroom fixtures are dated. The men's lavatory is cracked.

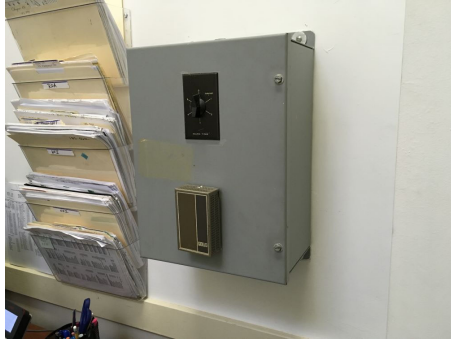
#	Issue	Photos
477	Time Clock Noise <i>Second Floor Rear Right Office</i> - The time clock in the second floor rear right office frequently makes a humming noise. It is assumed this is related to lighting or other controls for the second floor meeting room.

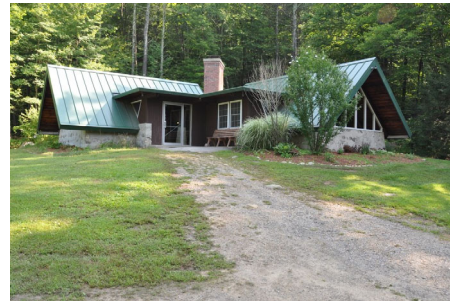
483 Entrance Not Accessible

Main Entrance to Enclosed Building - The main entrance to the enclosed building is not accessible due to various issues including, but not limited to, too much slope in pathway to entrance, step at entrance, etc.

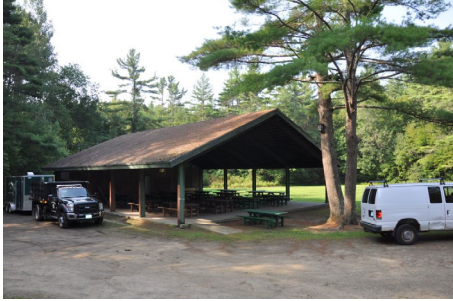
#	Issue	Photos
484	Ramp at Open Structure Not Accessible <i>Front</i> - The ramp to the main floor of the open structure does not have handicapped railings.

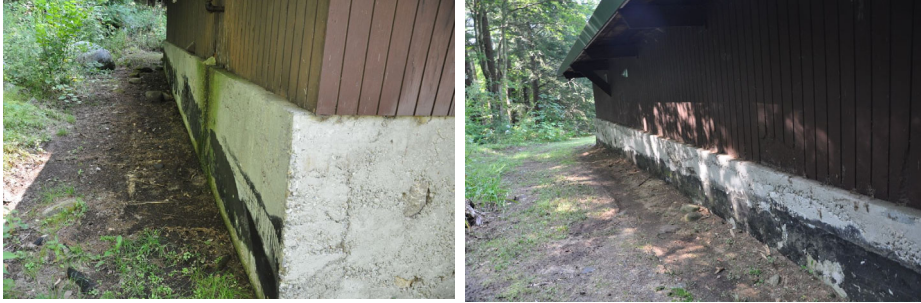
485	Damaged Exterior Walls <i>Rear and Rear Side Walls</i> - The dampproofing at the rear and rear side walls have deteriorated.

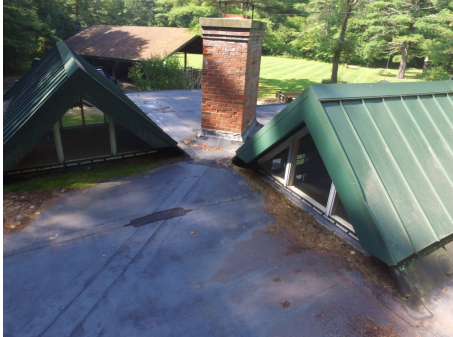
486	Minor Roof Leak(s) <i>Various Locations (incl. Mechanical Room)</i> - There appears to be minor roof leaks. The sloped roof is metal panel and the flat roof is membrane roofing.

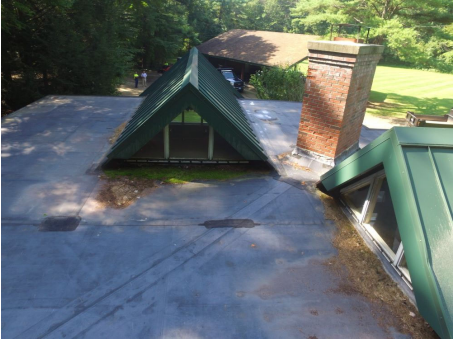
#	Issue	Photos
487	Roof Damage <i>Roof of Open Structure</i> - There are some holes in the existing roof. It was reported on-site that at one point there were plans to replace the roof with a metal roof. It is unclear if this work is going forward.

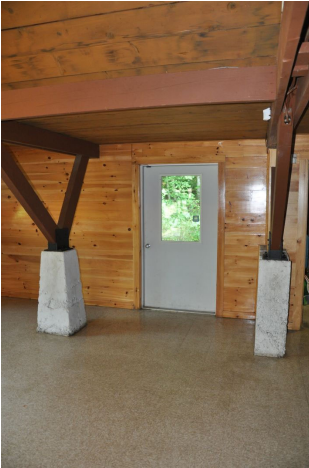
488	Secondary Egress Hardware Not Accessible <i>Various Locations</i> - There are two egress doors other than the main entrance that do not have lever handles.

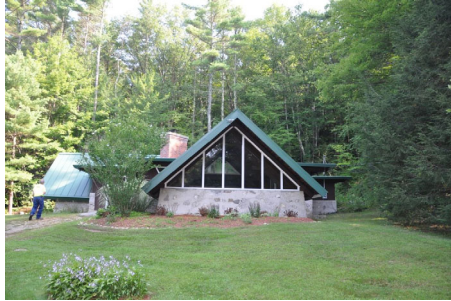
#	Issue	Photos
489	Window Paint Peeling (Large Windows) <i>Exterior, Various Locations</i> - The window paint is peeling on the exterior.

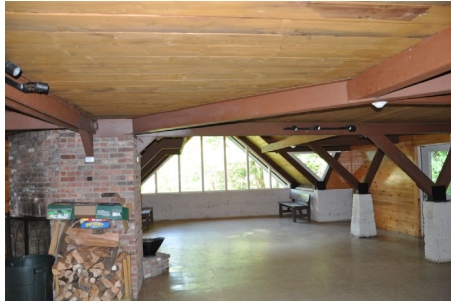
490	VCT Floor Wear <i>Entire Building</i> - The VCT is in fair to good condition, but will need to be replaced over the next 10 years.
